CAASLE Project, Phase III

***Presented by
Michael McClendon - Upper Basin Regional Manager
&
Stewart Vaghti P.E. - Gannett Fleming Inc.***

Morris Sheppard Dam

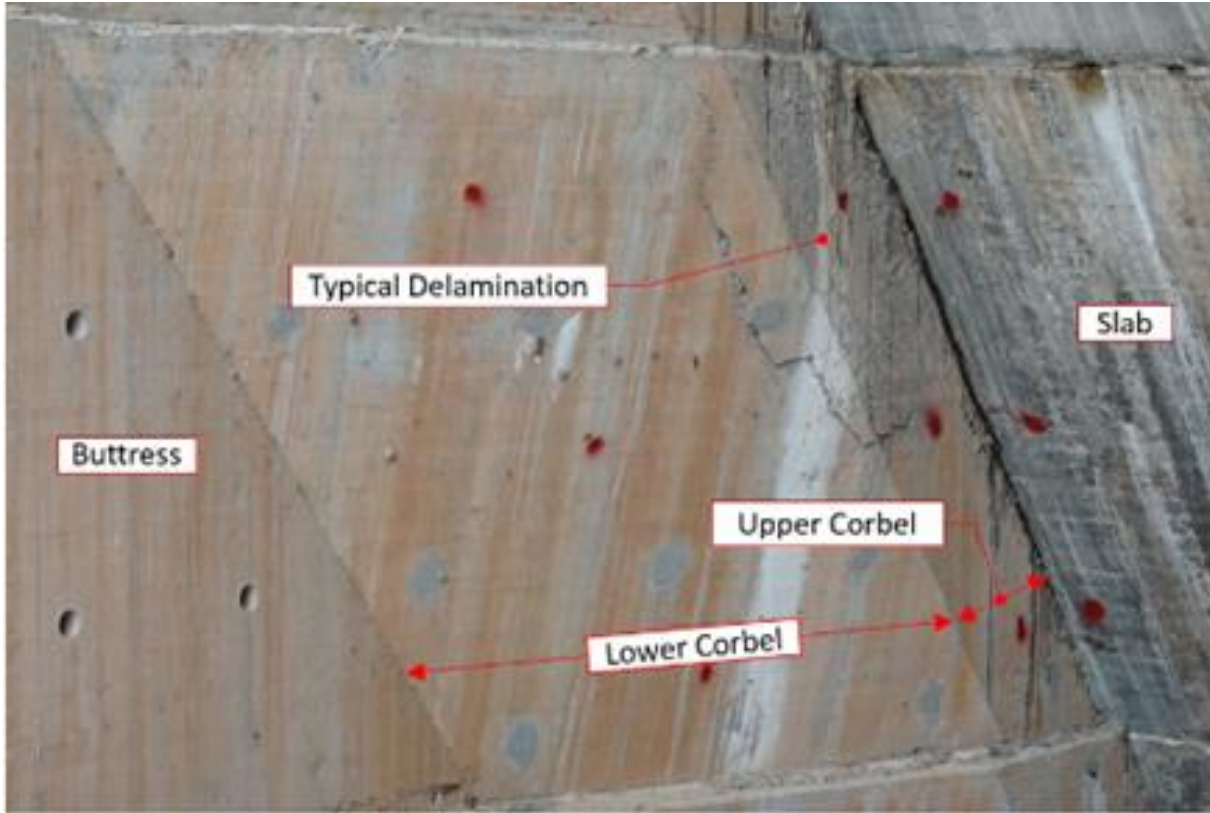
Figure 6-1 – Typical Corbel Delamination (Bay 31)

- Locations in the studied **non-overflow bays** (Bay 31 and Bay 1) were found to have test points where most or all NDE methods used identified a potential defect in the concrete.
- The **non-overflow** bays tested identified significantly shallower delaminations of the upper **corbel regions** compared to the spillway bays tested. Some delaminations are also visually evident by surface cracking, and various stages of spalling.

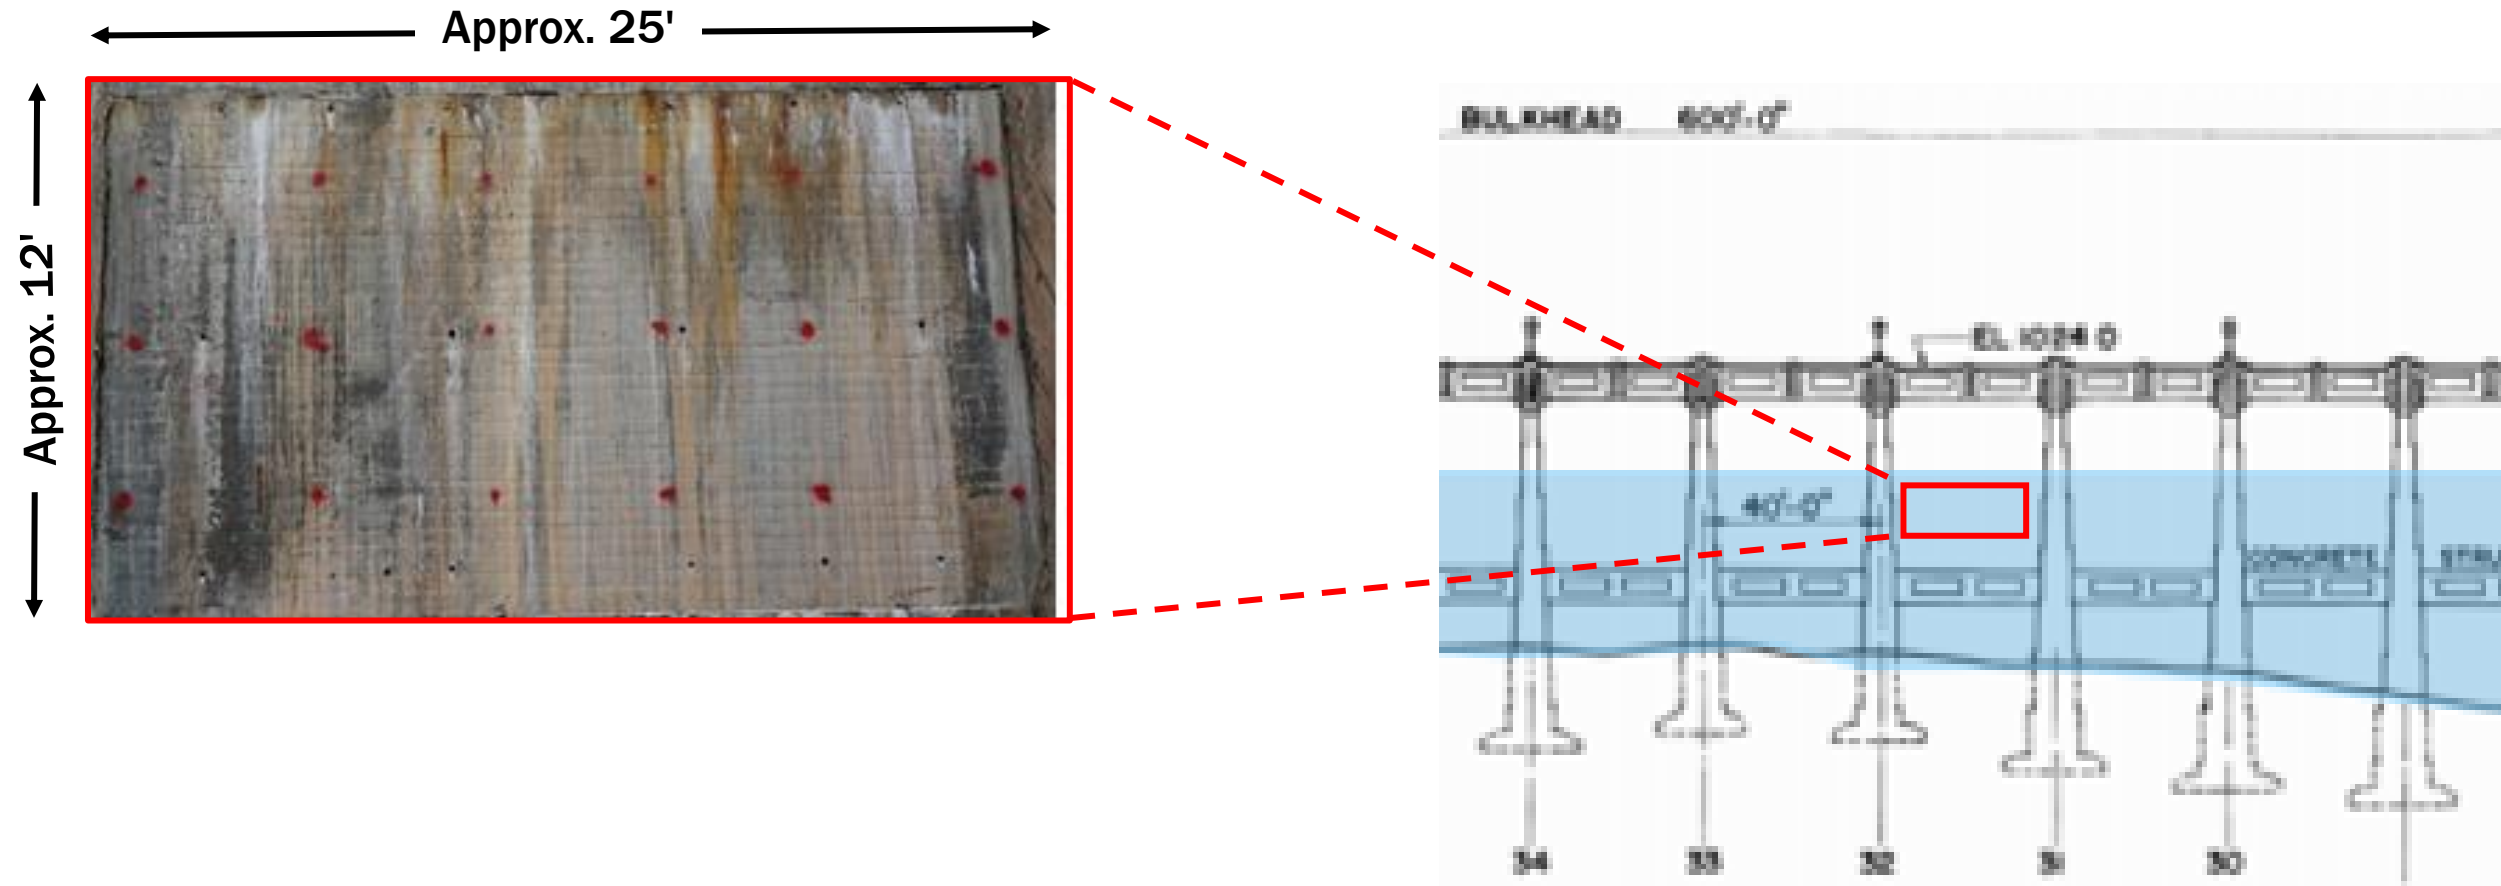
- The **non-overflow bays** tested identified areas of shallow delaminations of the downstream sides of the upstream **slabs**, whereas the spillway bays tested identified no areas of slab delaminations. No visual evidence of cracking or spalling was observed at the areas of delaminations identified.

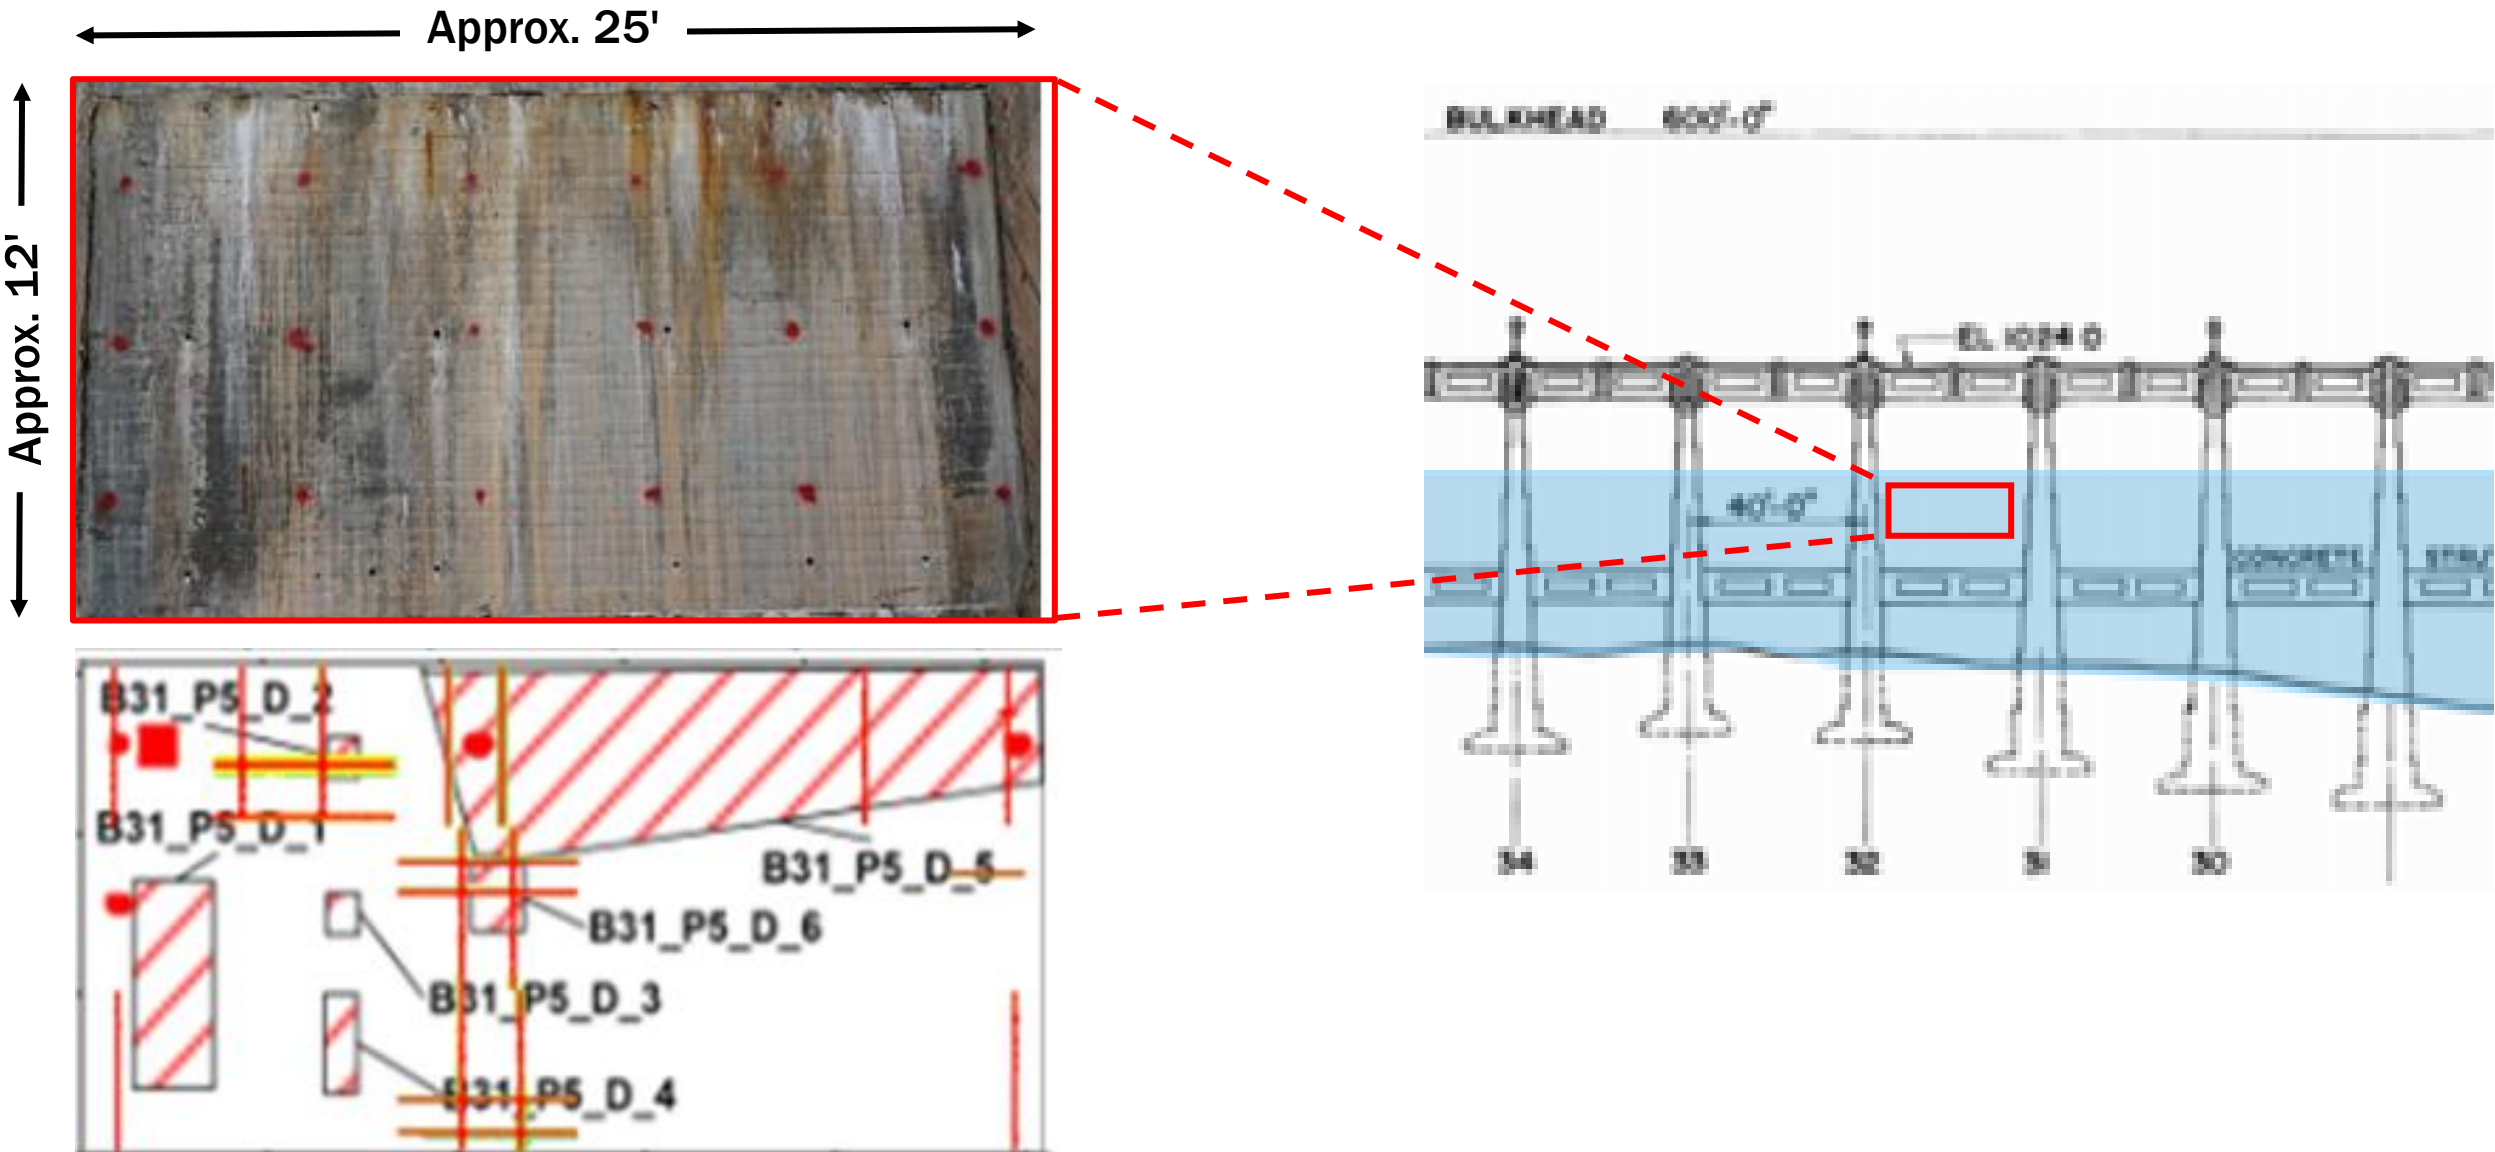
- The **non-overflow bays** tested identified areas of shallow delaminations of the downstream sides of the upstream **slabs**, whereas the spillway bays tested identified no areas of slab delaminations. No visual evidence of cracking or spalling was observed at the areas of delaminations identified.
