Stormwater/Effluent Runoff & Environmental Concerns

Prepared by Neighbors for the Protection of Willow Beach Slough
Possum Kingdom Lake, Texas
May 24, 2021

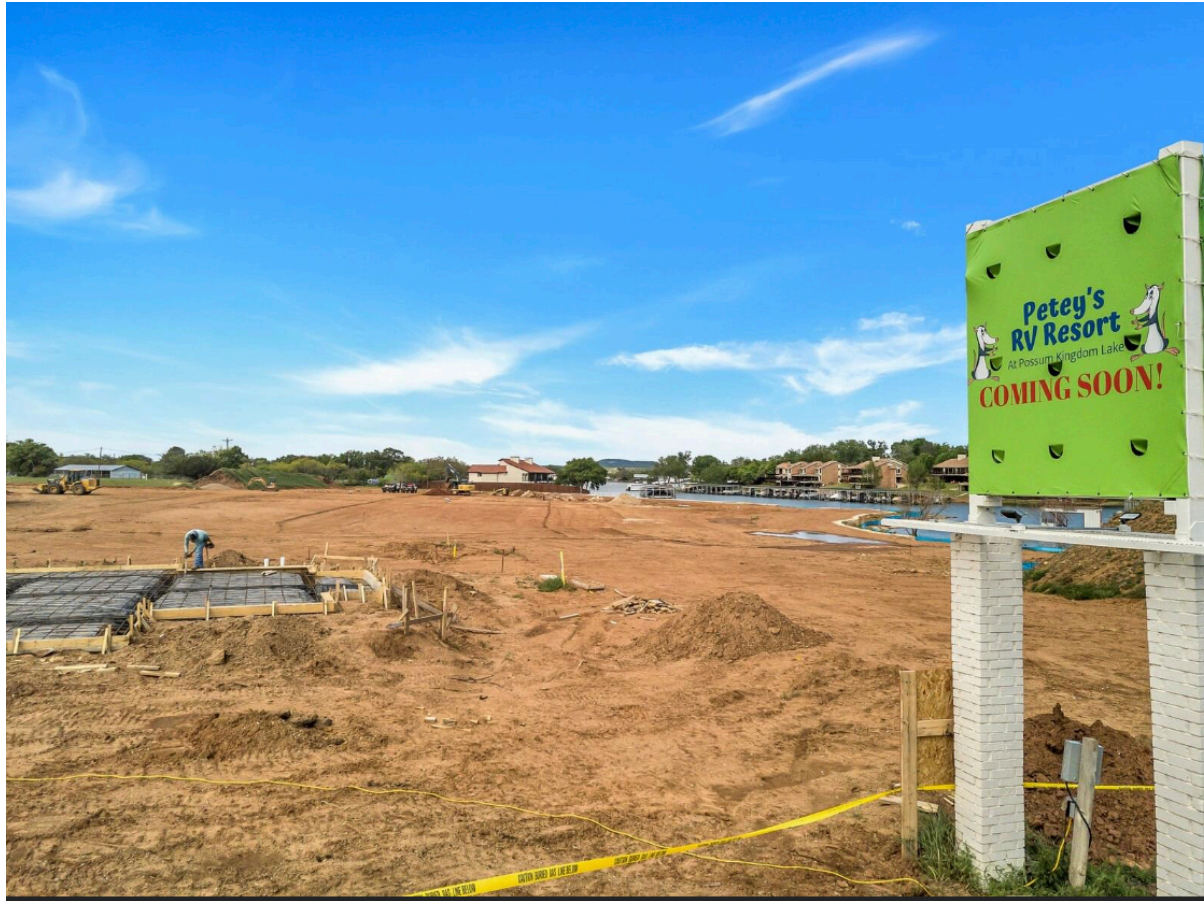
Before...

- Every inch of the soil on the property has been disturbed
- All vegetation has been removed
- Caliche roads and pavement to cover the property
 - Where will the vegetation be?
 - Vegetation and undisturbed soil allows for:
 - Increased saturation
 - Impeded runoff flow
 - Adequate stormwater runoff filtration

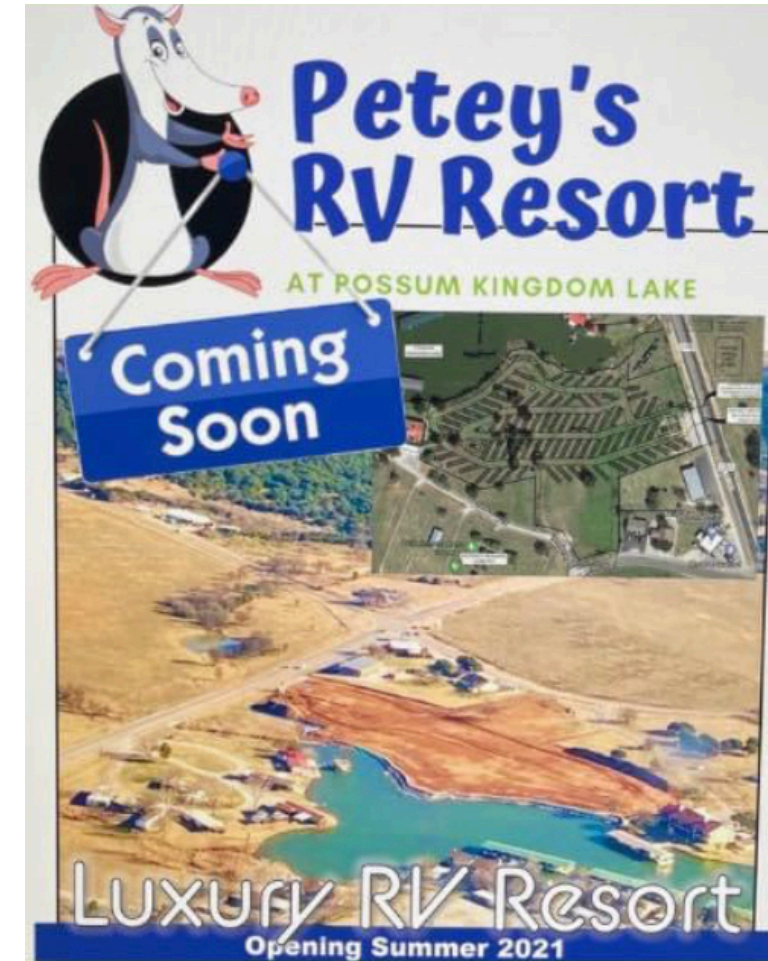
After...

Soil Disturbance, Minimal Vegetation, and Impervious Surfaces
