***Sterling C. Robertson Dam Tainter
Gate Replacement Project
Professional Services Contract with
Stantec Consulting Services, Inc.***

***Presented by
Brad Brunett, Central and Lower Basin Regional Manager
and Bill Swanson of Stantec Consulting Services, Inc.***

Meeting Date: April 30, 2018

Sterling C. Robertson Dam

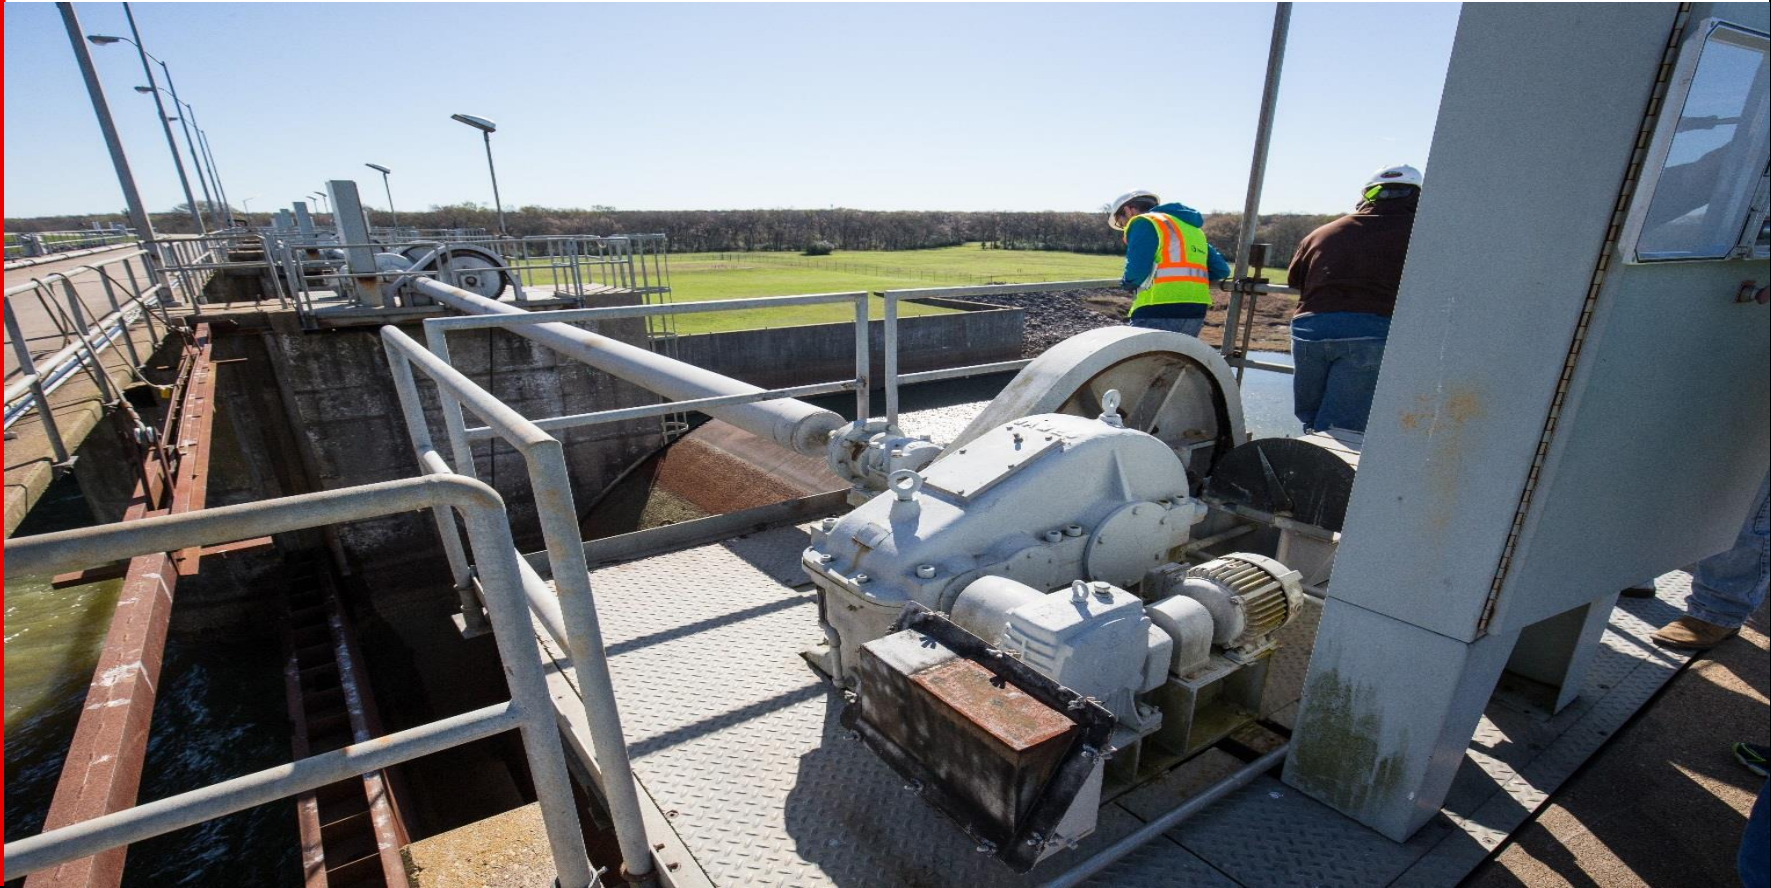
View Across Top of Dam

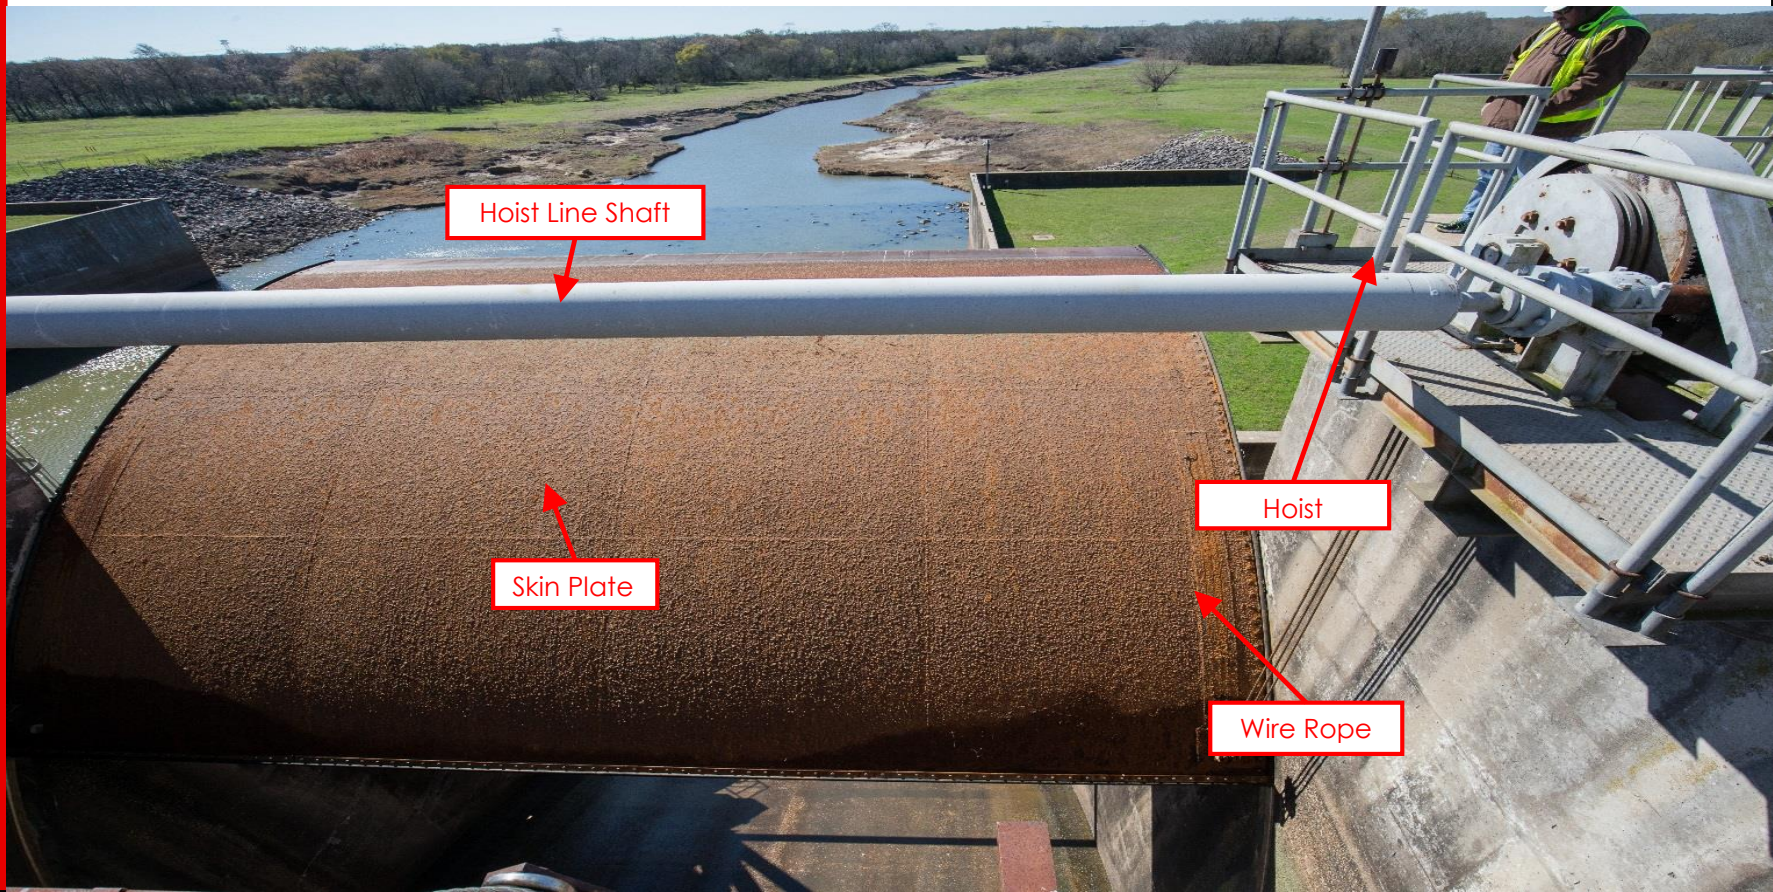
Typical Gate

- **Constructed in 1978**
 - 40 years old
- **5 Radial Tainter Gates**
 - 40 feet wide by 29 feet high
 - “Weathering steel” has performed poorly in a submerged application
- **Gate Hoists**
 - Also 40 years old
 - Previous study recommended rehabilitation
 - Could be affected by gate modifications

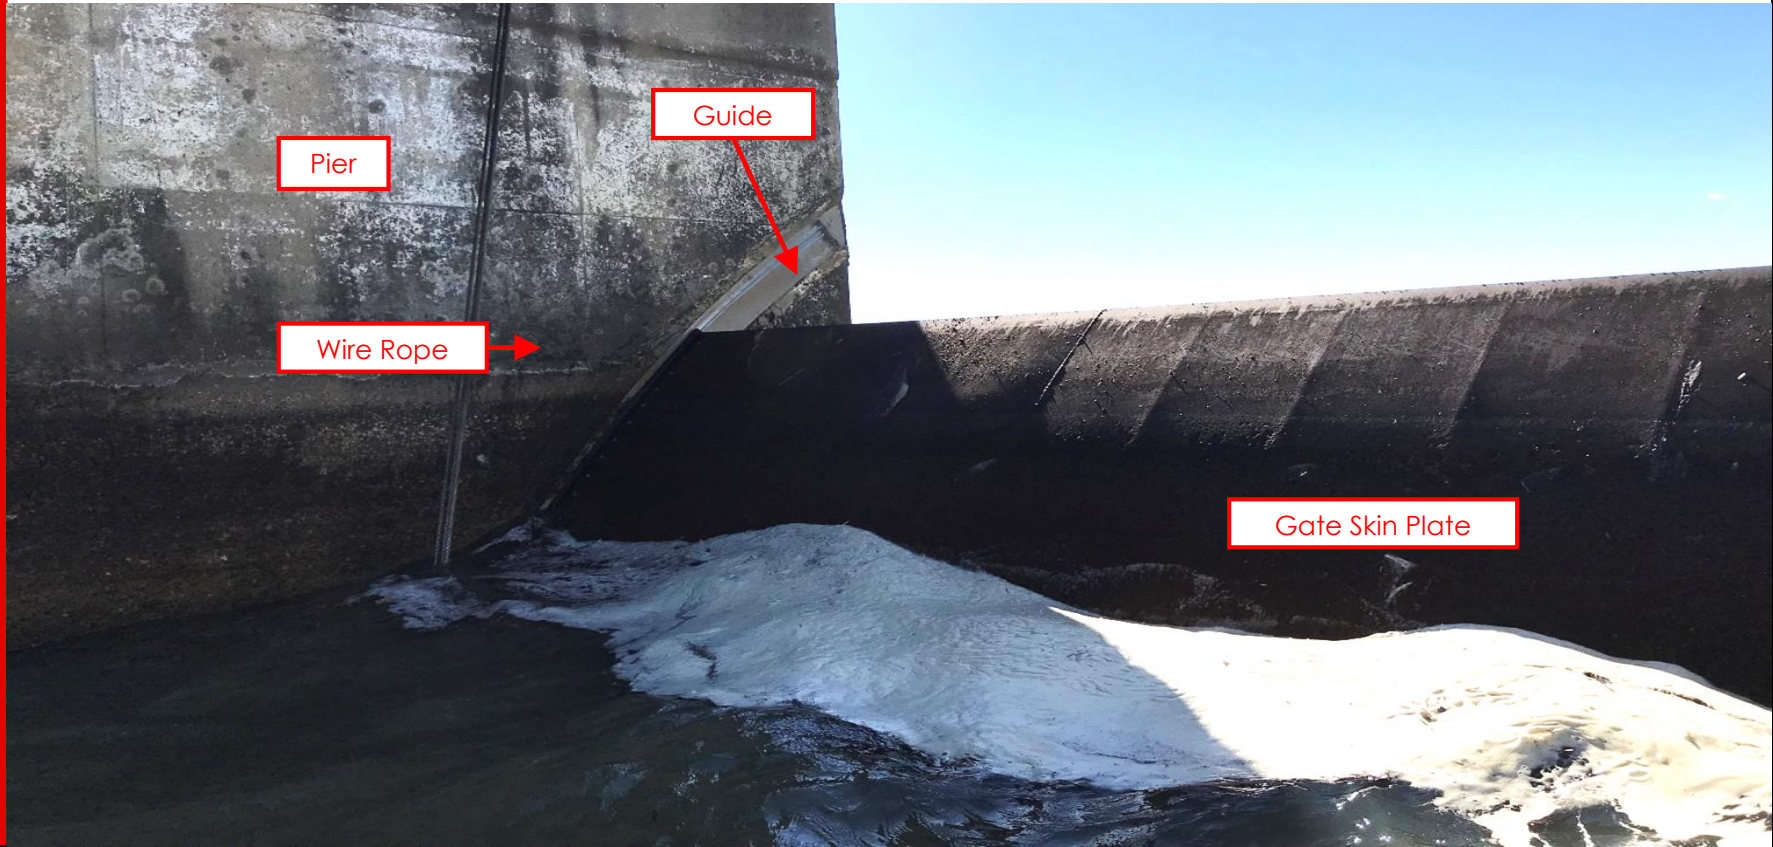
Upstream Face of Gate

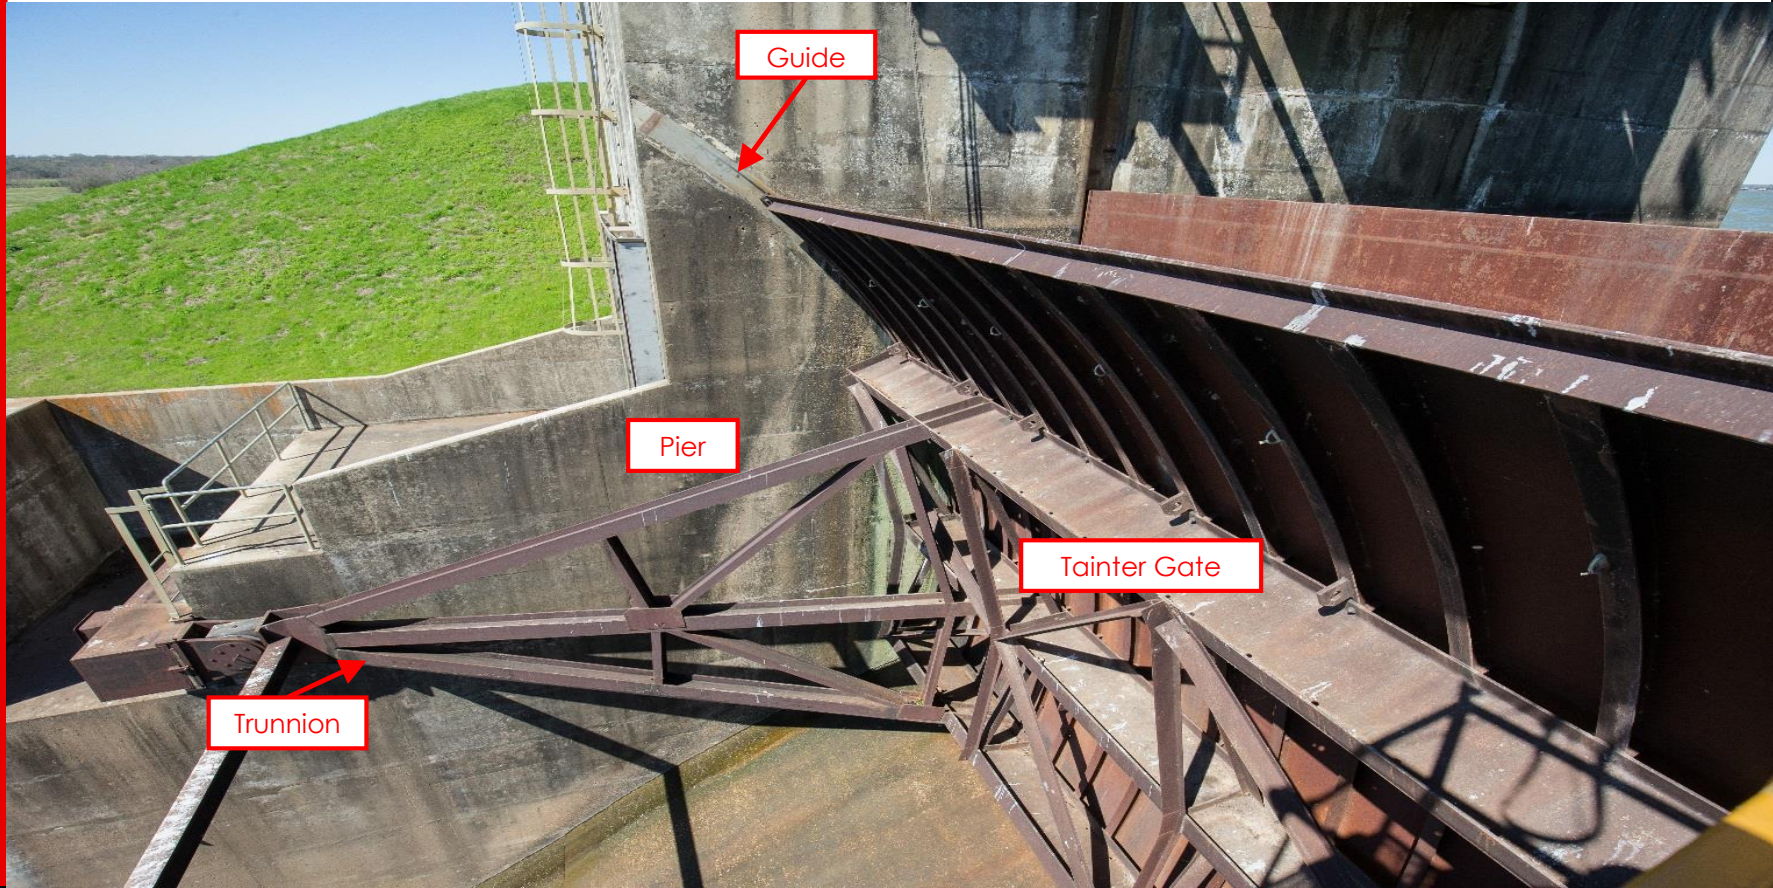
Gate Bay Components

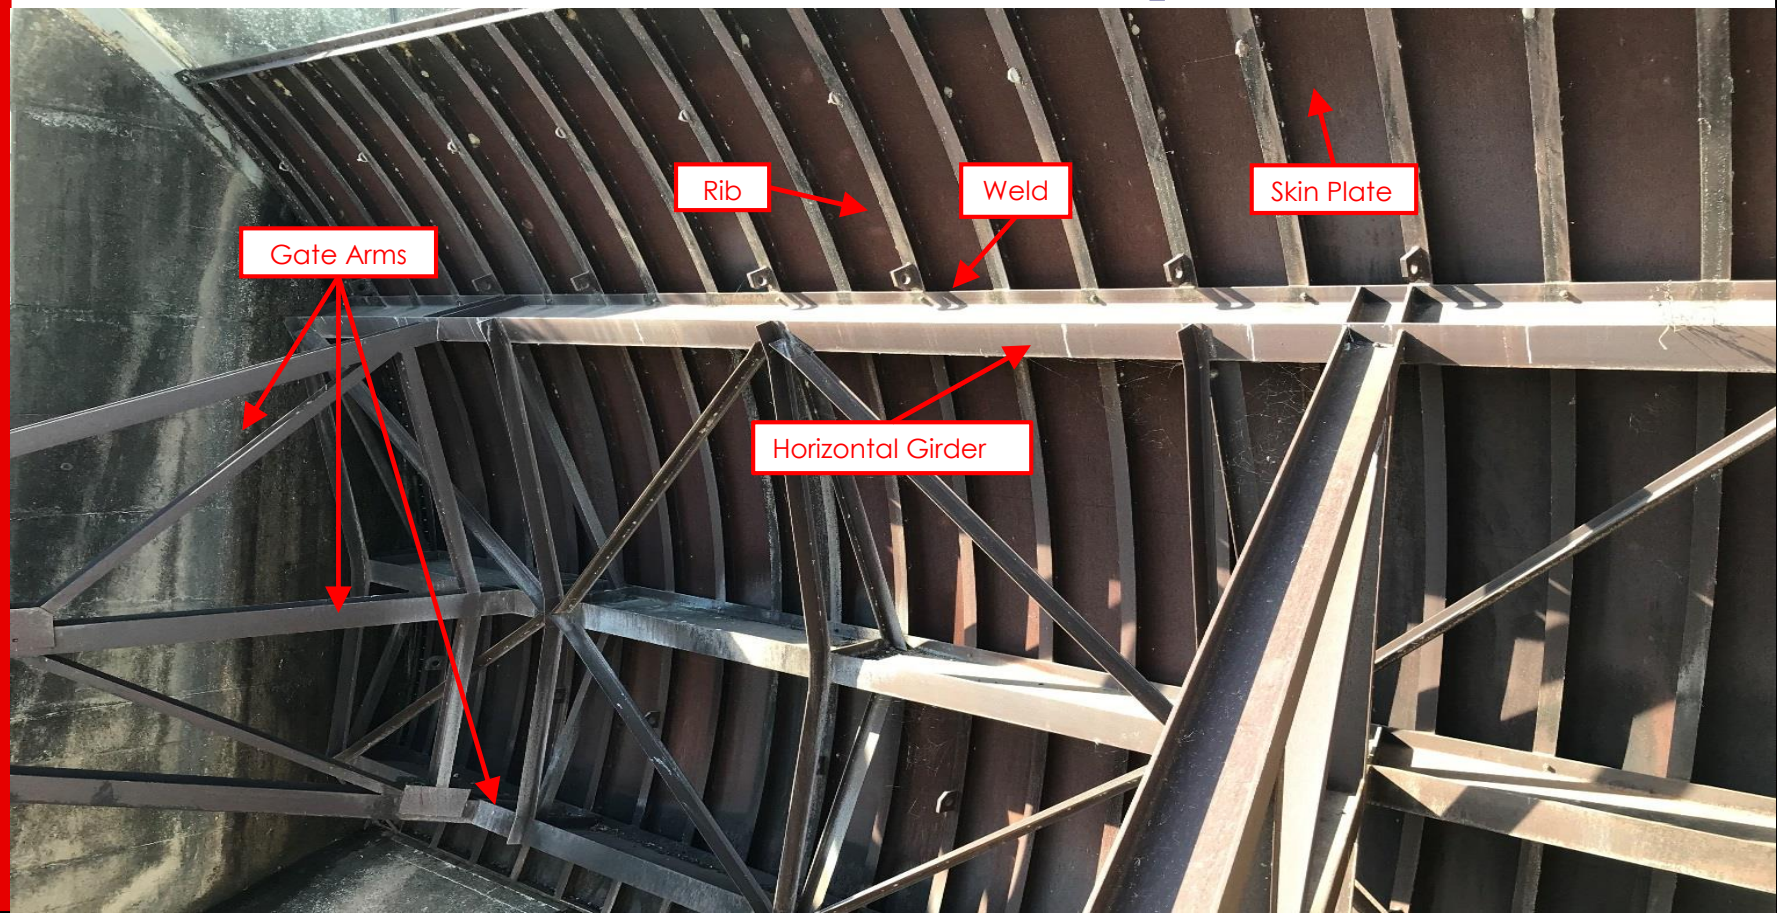
Tainter Gate Components

Gate Arms

Rib

Weld

Skin Plate

Horizontal Girder

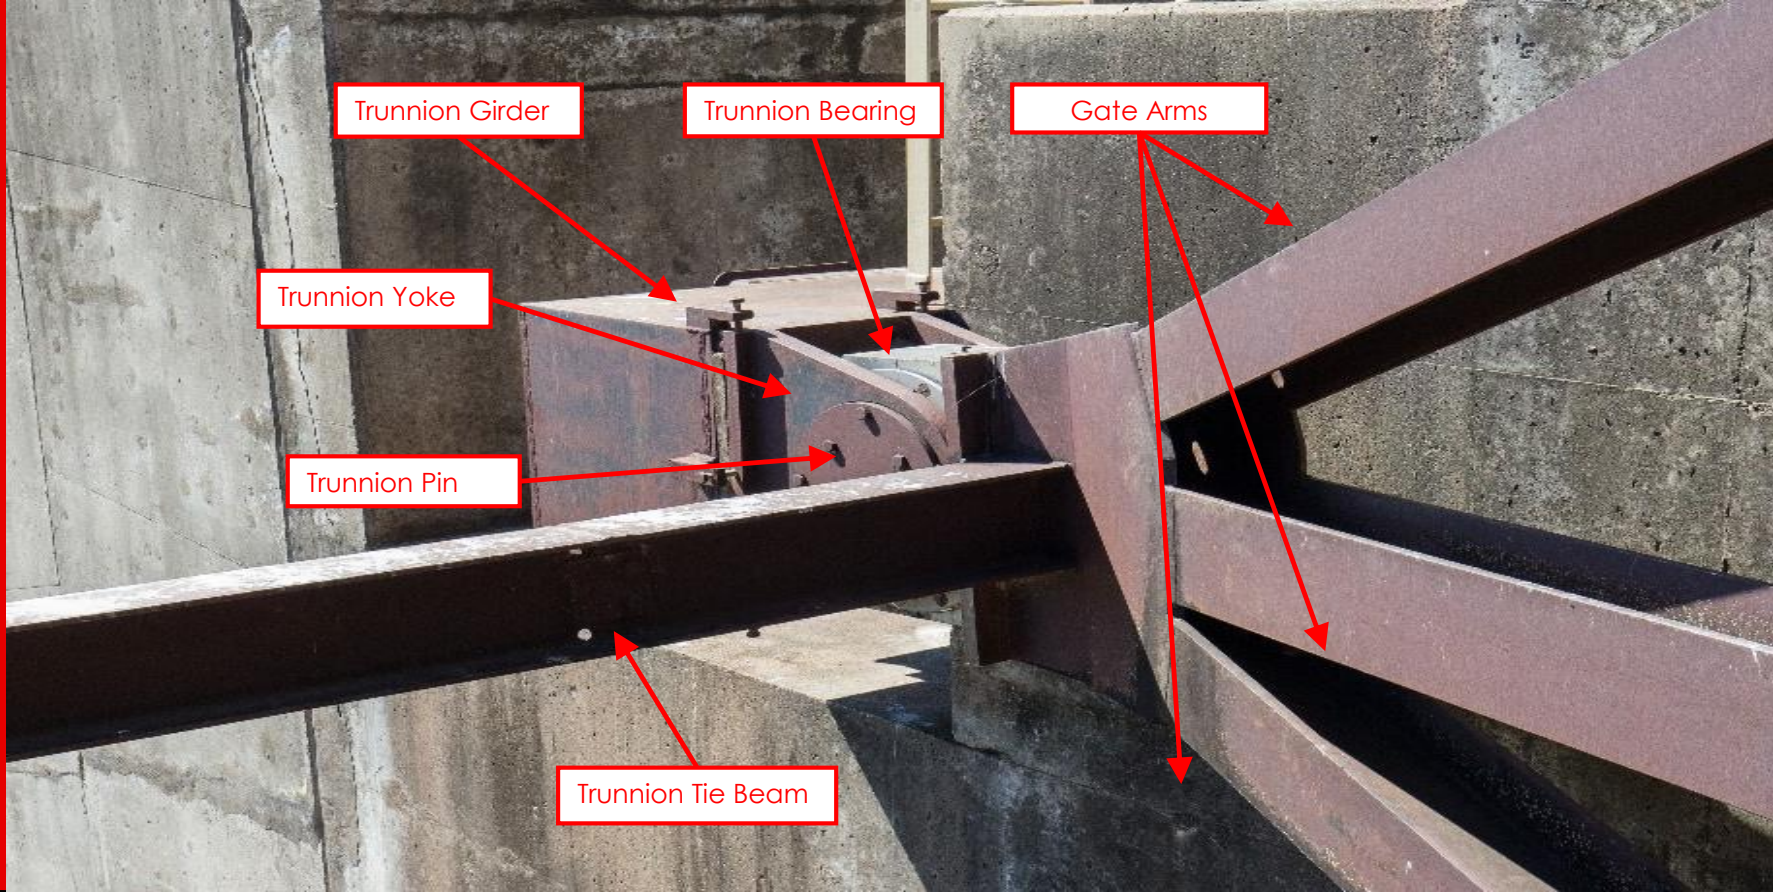
Trunnion Components
