CAASLE Project, Phase II

Presented by
Michael McClendon - Upper Basin Regional Manager
&
Stewart Vaghti P.E. - Gannett Fleming Inc.

Morris Sheppard Dam

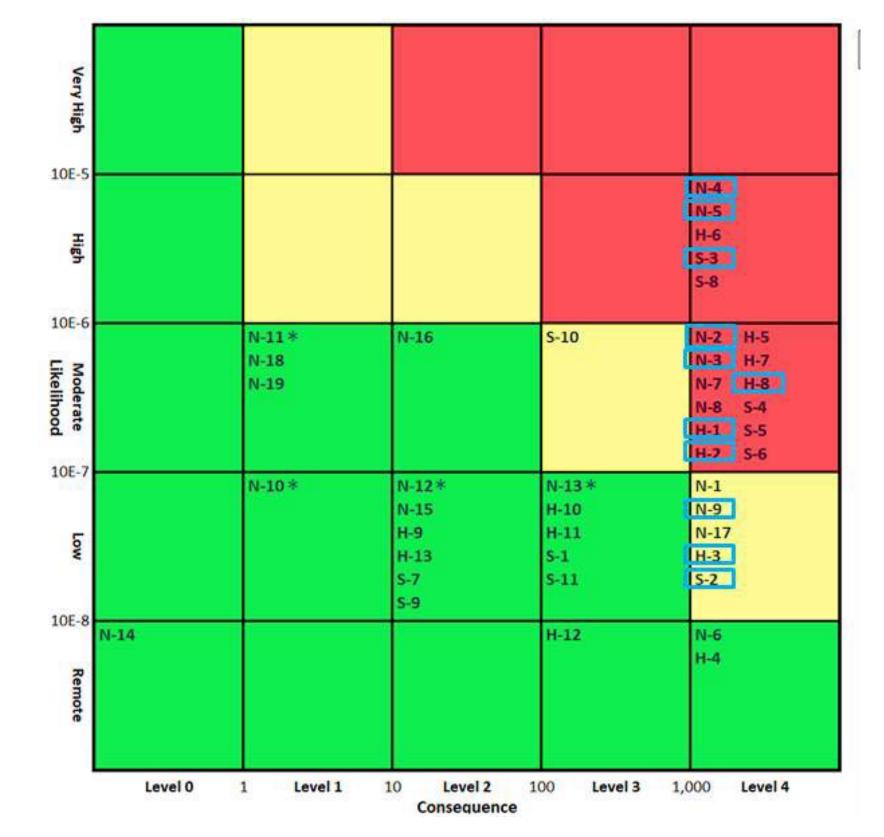
SQRA f-N Chart

- What is it?
- What were findings?
- How will it be used?

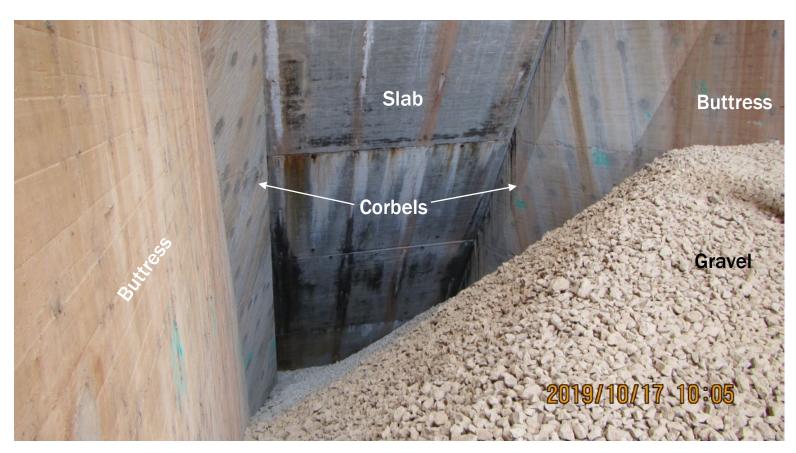
10 upstream
5 downstream

<u>Section</u>

Elevation

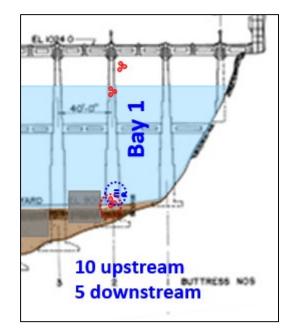
Active Delamination

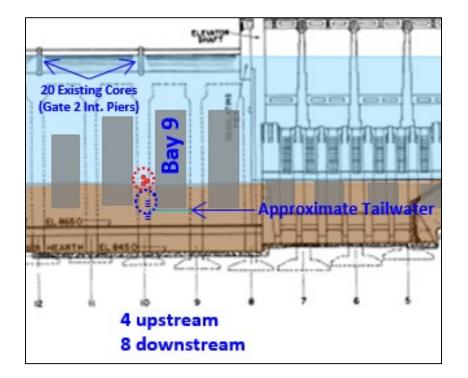
Collapsed Concrete Pipe

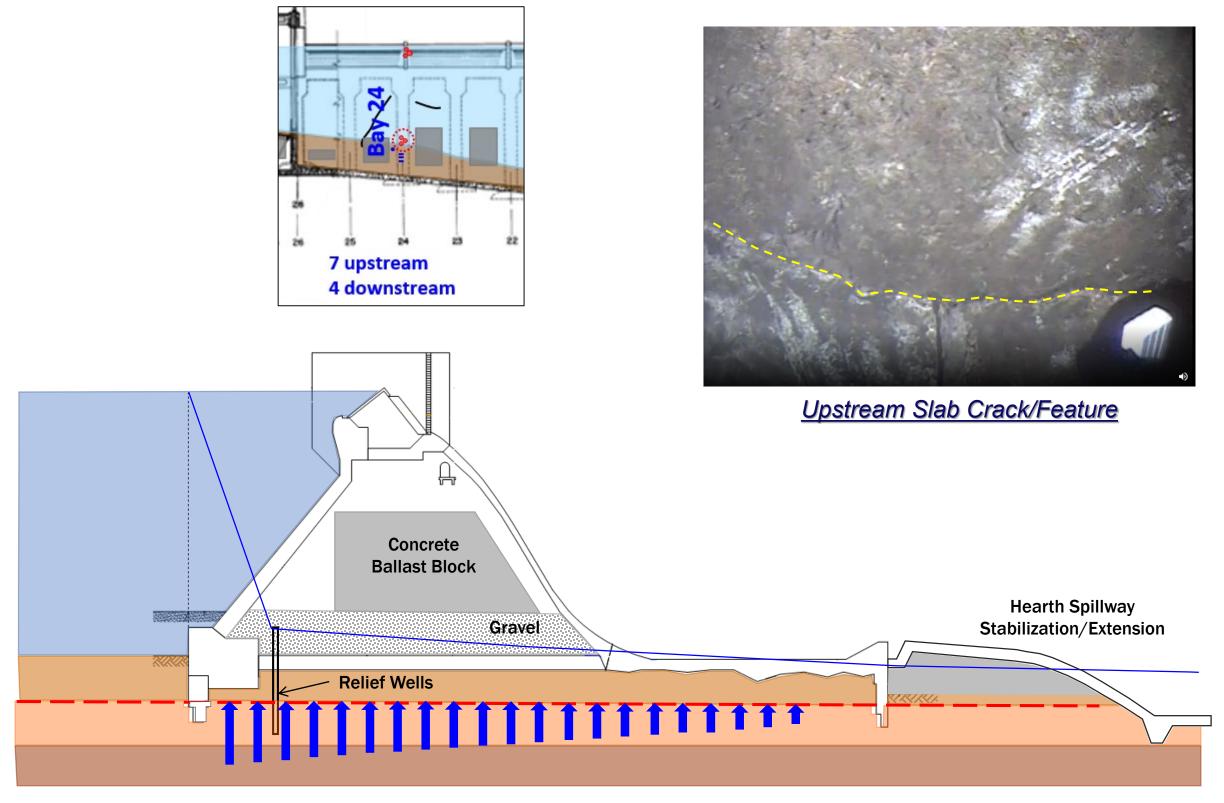
Meeting Date: January 27, 2020 <u>Deteriorated Concrete</u>

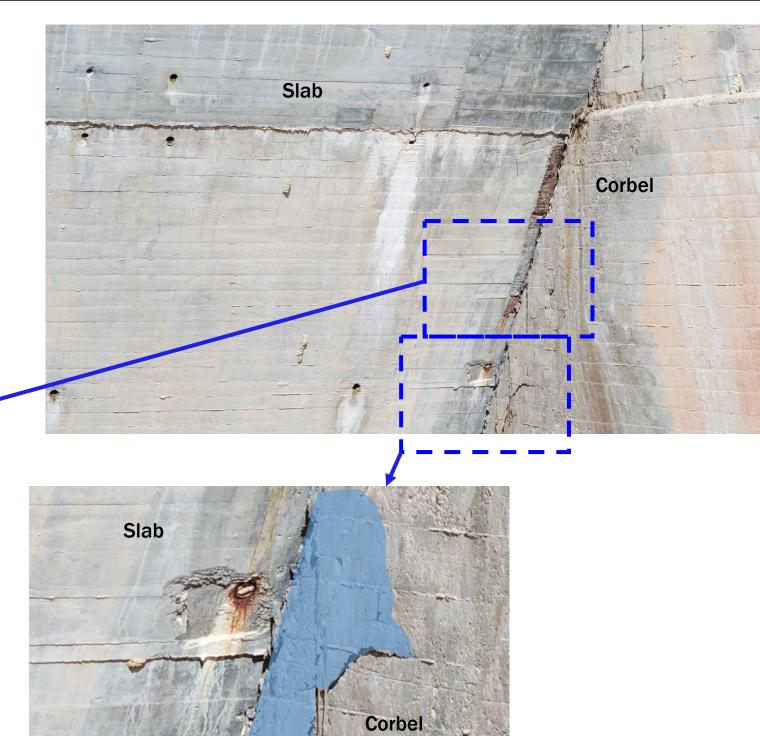
Active Delamination

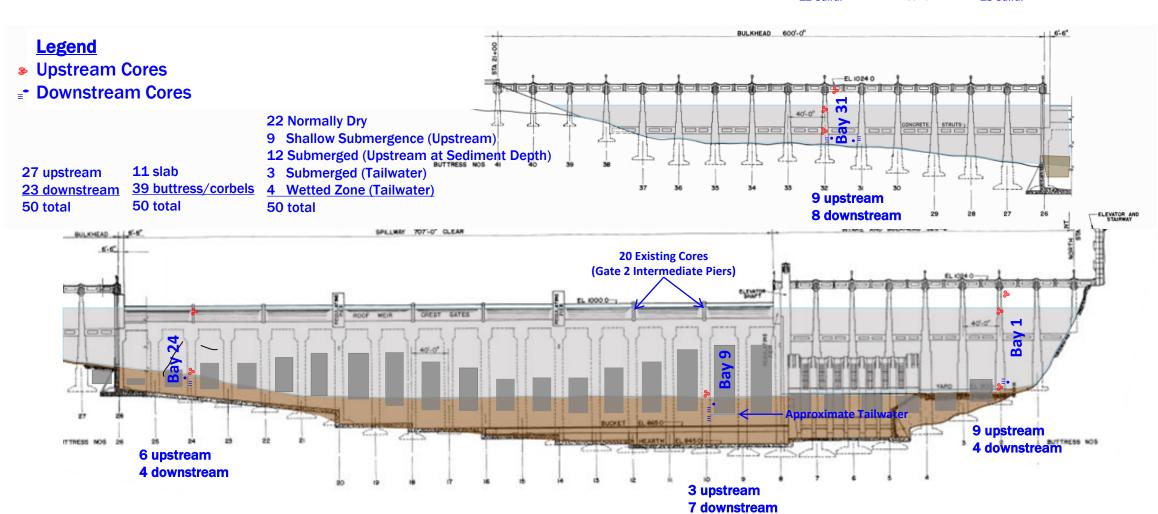
Concrete Coring
