# **Brazos River Basin Highlights Report 2018**

The Brazos River Authority, as a member of the Texas Clean Rivers Program, works to answer questions about the quality of our local streams, rivers and lakes in the *Brazos River Basin Highlights Report 2018*. This report is a programmatic update that contains information and updates on on-going activities and projects that address water quality concerns in the lakes and streams of the Brazos River basin. It also summarizes the results of the 2014 Integrated Report (IR).

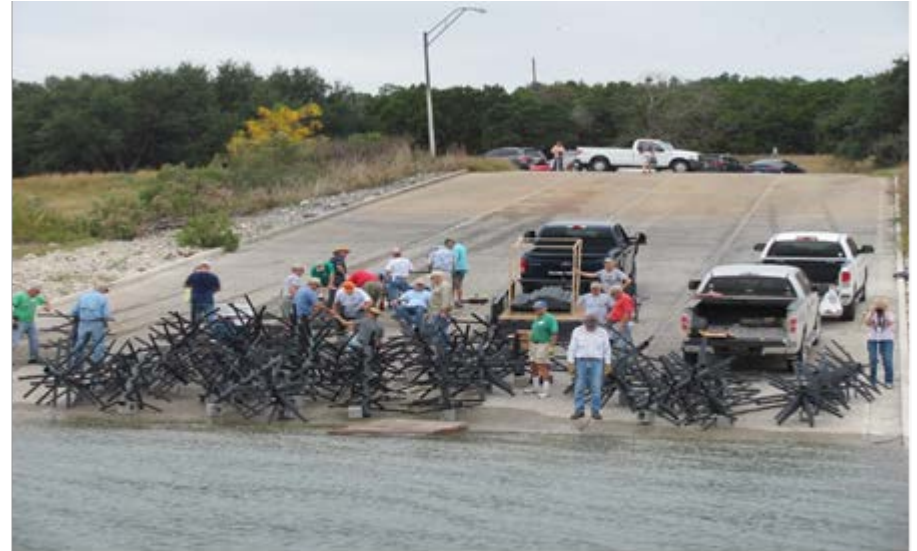
Offshore view of the Sun City Hunting and Fishing Club readying artificial habitat structures for deployment into Georgetown Reservoir, November 7, 2017.
