# Bosque River Watershed

# North Bosque TMDL

# North Bosque River TMDL

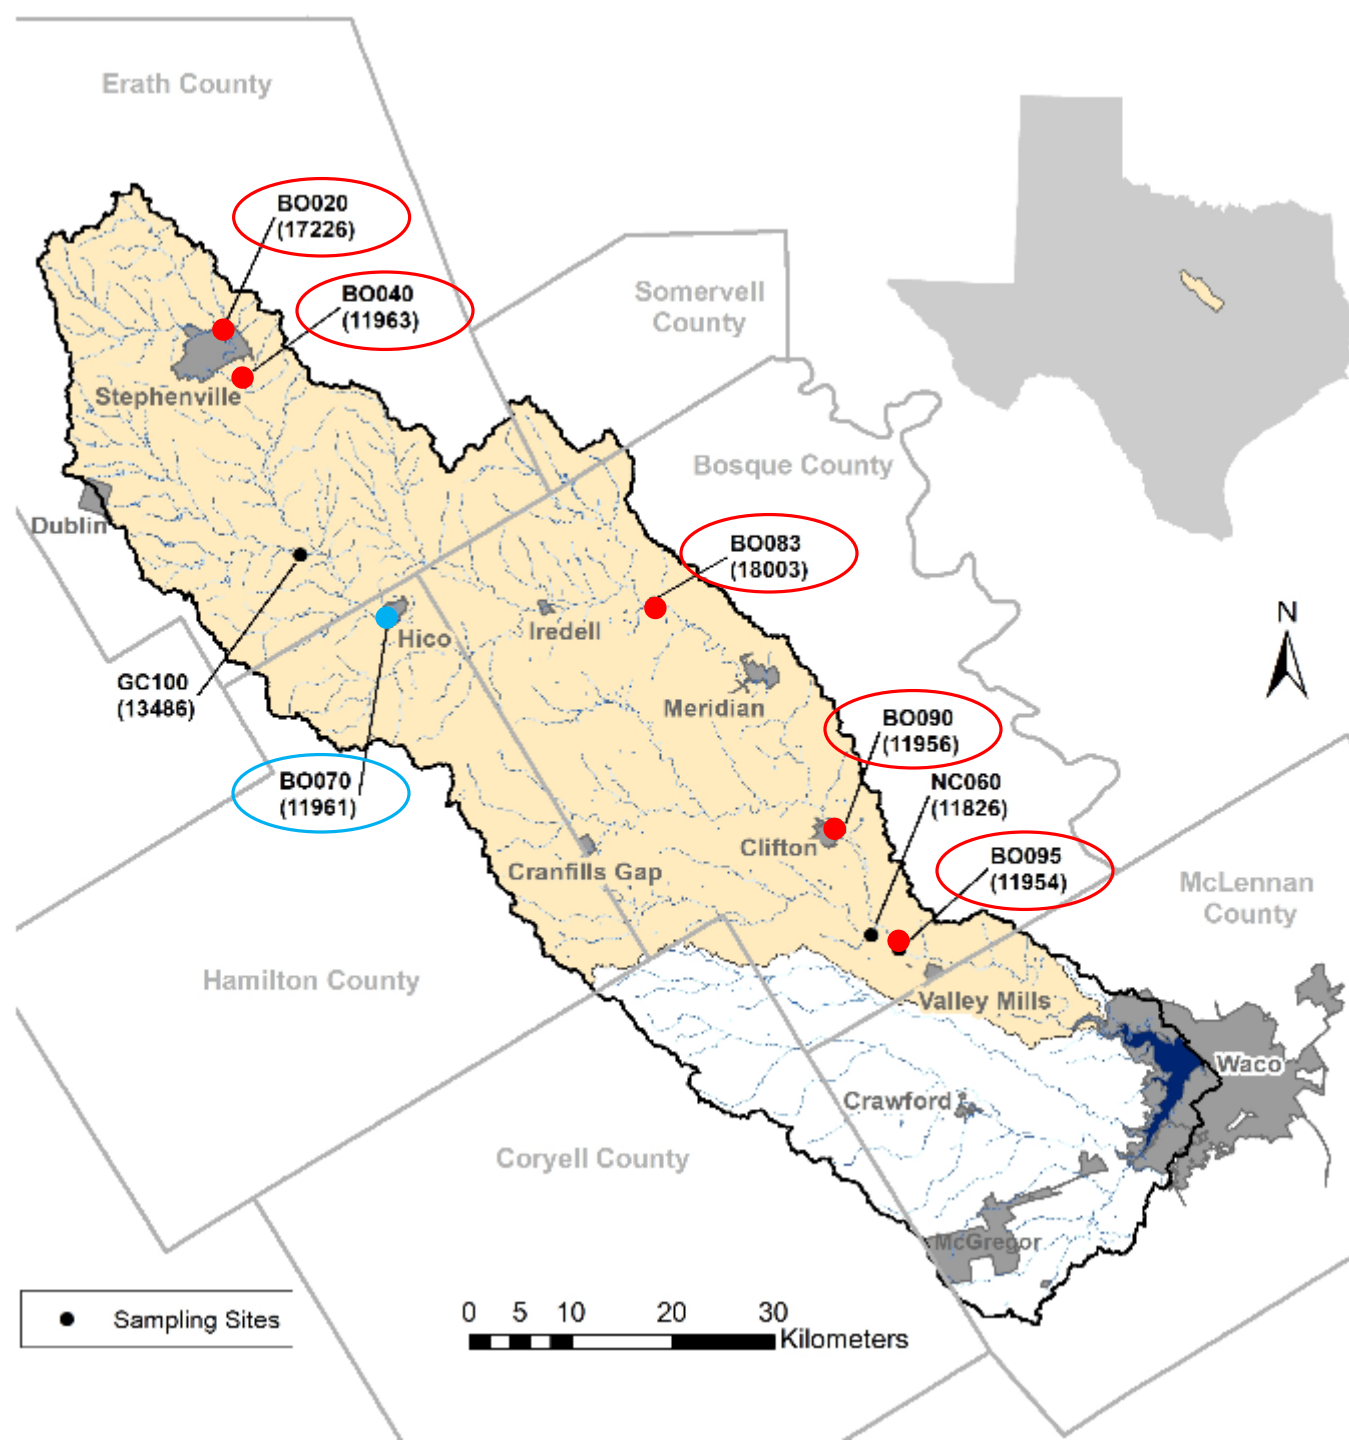
# North Bosque Monitoring Stations

Index  
Stations  
circled in  
Red

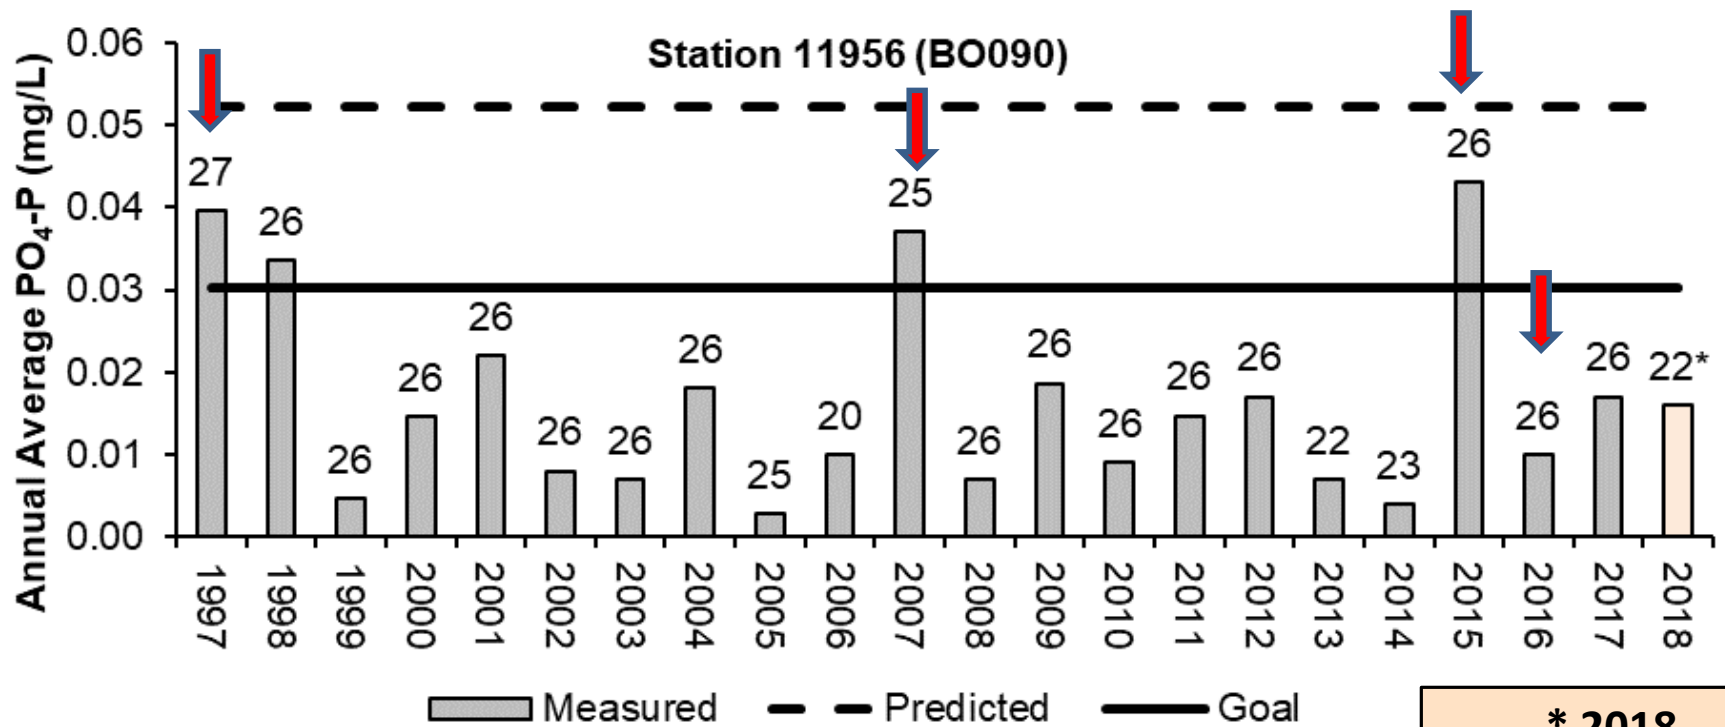
**Station 11956  
located near  
Clifton**

**\* 2018  
Provisional Data**
