Brazos River Basin Highlights Report 2026

Brazos River Authority

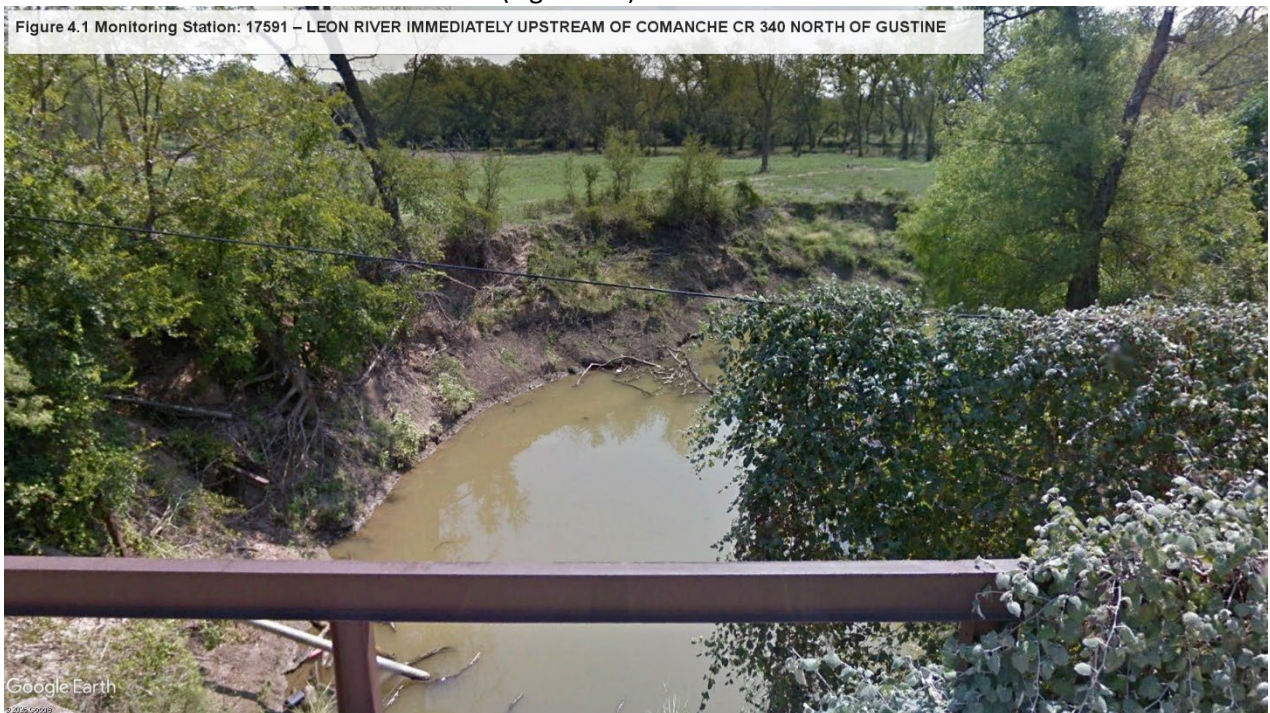
- 1221_06: Leon River Below Lake Proctor, from confluence with South Leon Creek upstream to confluence with Walnut Creek
Monitoring Station: 17591 - LEON RIVER IMMEDIATELY UPSTREAM OF COMANCHE CR 340 NORTH OF GUSTINE (Figure 4.1)

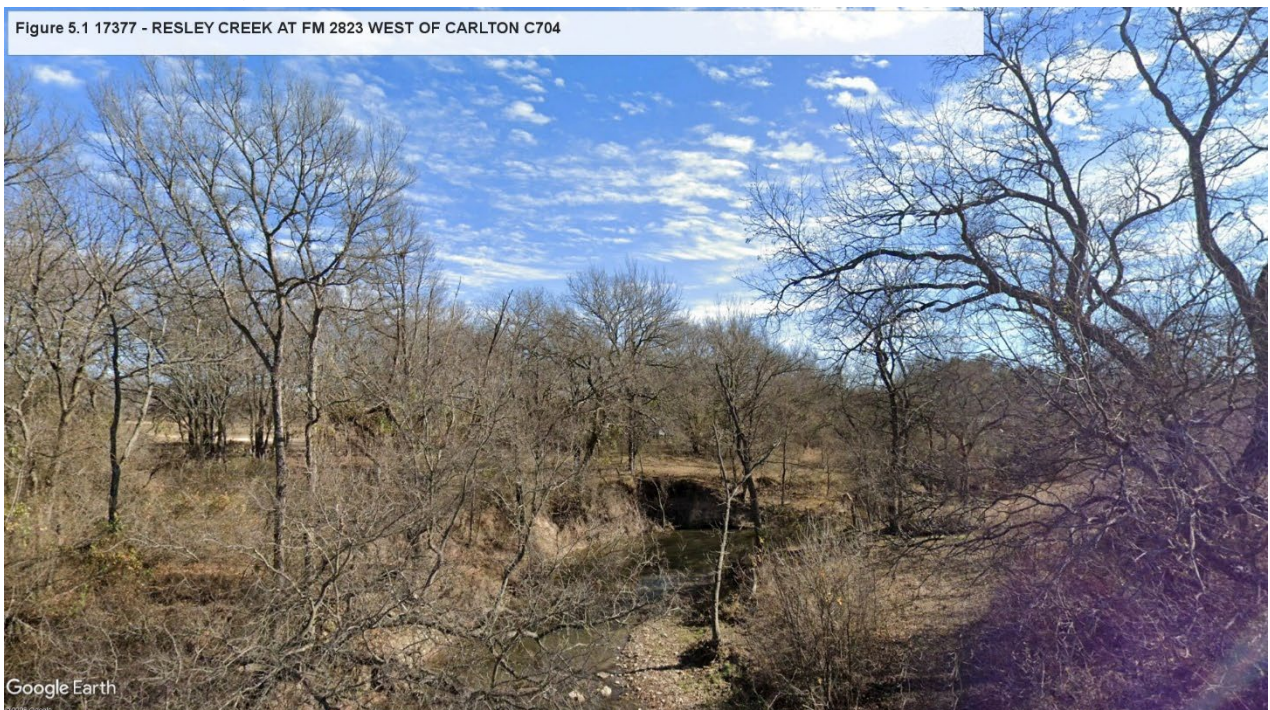
- 1221_05: Leon River below Lake Proctor, from confluence with Pecan Creek upstream to confluence with South Leon Creek
Monitoring Station: 18781 - LEON RIVER AT HAMILTON CR 109
- 1221A_01: Resley Creek, from confluence of Leon River upstream to confluence with unnamed tributary (NHD RC 12070201007823), approx. 1.0 mile N of Comanche County Line
Monitoring Station: 17377 - RESLEY CREEK AT FM 2823 WEST OF CARLTON C704 (Figure 5.1)

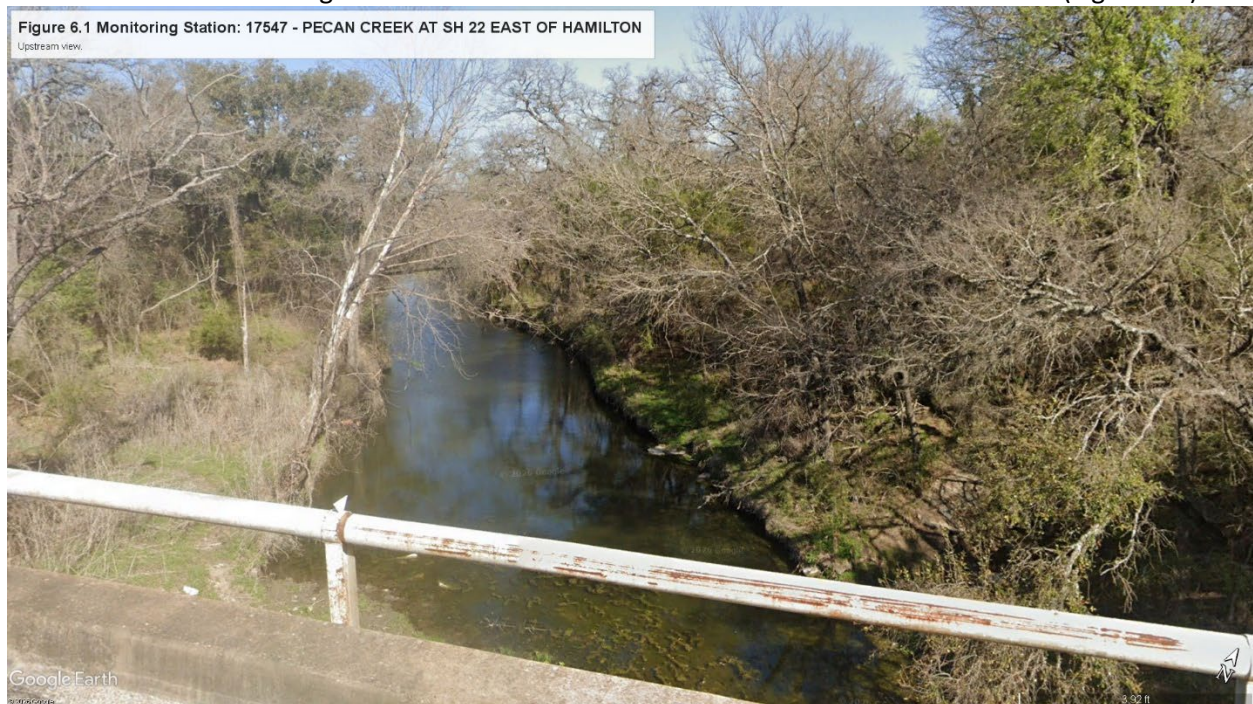
- 1221_05: Leon River below Lake Proctor, from confluence with Pecan Creek upstream to confluence with South Leon Creek
Monitoring Station: 20905 - LEON RIVER AT HAMILTON CR 203 NORTH OF HAMILTON
- 1221_04: Leon River Below Proctor Lake, From a point immediately upstream of the confluence of Plum Creek in Coryell County to Proctor Dam in Comanche County
- 1221C_01: Pecan Creek, Perennial stream from the confluence with the Leon River upstream to the confluence with an unnamed tributary approximately 3.5 km upstream of SH 36 near the City of Hamilton; App D
Monitoring Station: 17547 - PECAN CREEK AT SH 22 EAST OF HAMILTON (Figure 6.1)

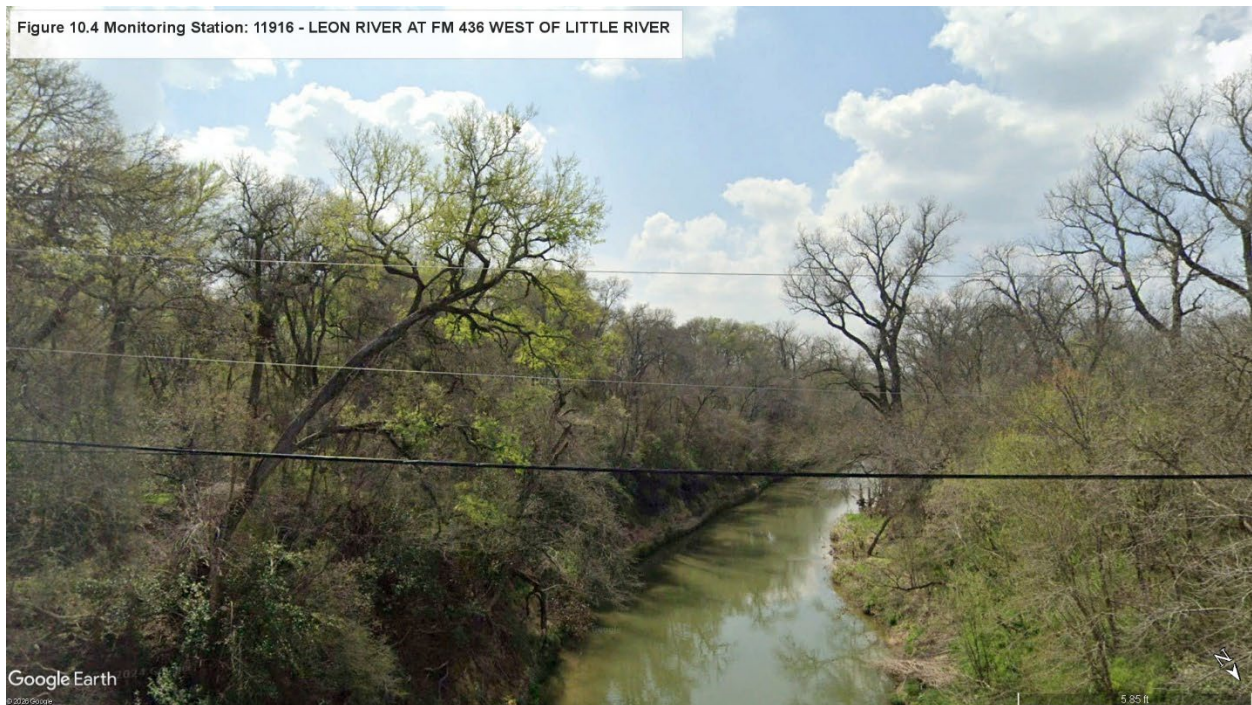
- 1219_01: Leon River below Lake Belton, From the confluence with the Lampasas River in Bell County to Belton Dam in Bell County
Monitoring Station: 11916 - LEON RIVER AT FM 436 WEST OF LITTLE RIVER (Figure 10.4)

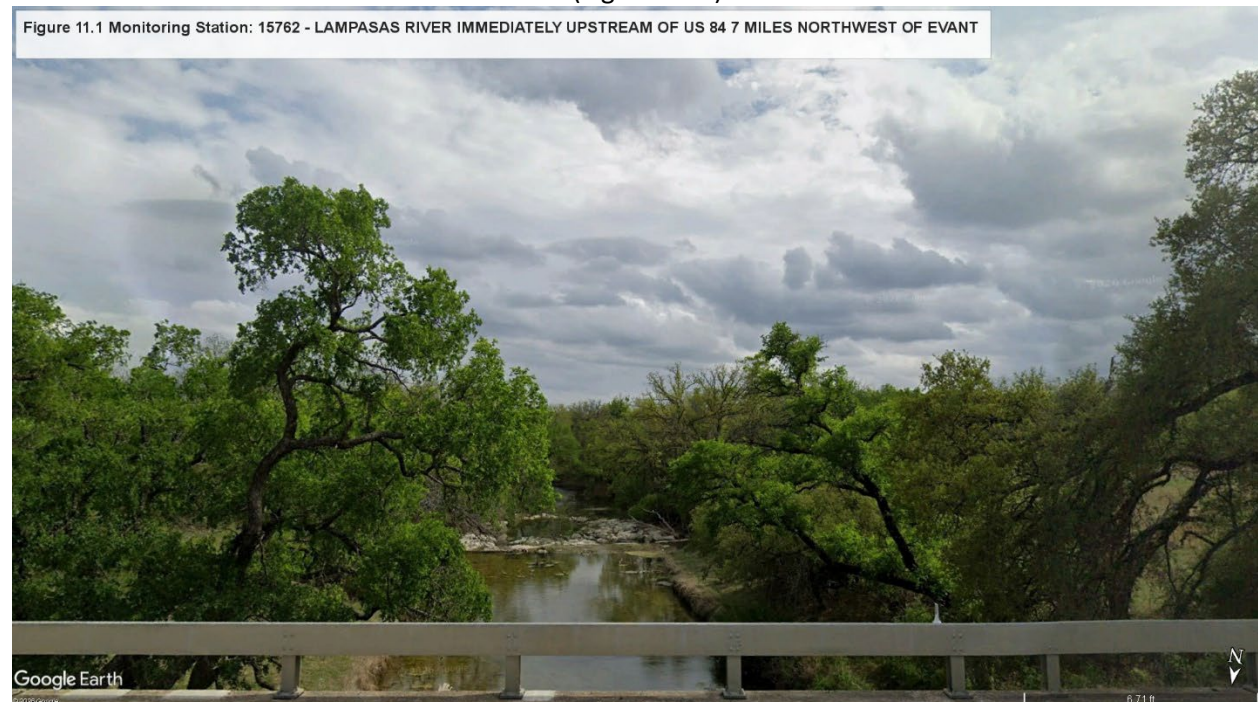
- Upstream portion of 1217_04: Lampasas River above Stillhouse Hollow Lake, Portion of Lampasas River from confluence with Simms Creek upstream to confluence with Bennett Creek in Lampasas County.
Monitoring Station: 15770 - LAMPASAS RIVER IMMEDIATELY UPSTREAM OF LAMPASAS CR 2925 FORMERLY KNOWN AS LAMPASAS CR 105 AND 10.5 KM NORTH OF ADAMSVILLE
- 1217_05: Lampasas River above Stillhouse Hollow Lake, Portion of Lampasas River from confluence with Bennett Creek upstream to its headwaters in Mills County.
Monitoring Station: 15762 - LAMPASAS RIVER IMMEDIATELY UPSTREAM OF US 84 7 MILES NORTHWEST OF EVANT (Figure 11.1)
