Stormwater/Effluent Runoff & Environmental Concerns

Prepared by Neighbors for the Protection of Willow Beach Slough
Possum Kingdom Lake, Texas
May 24, 2021

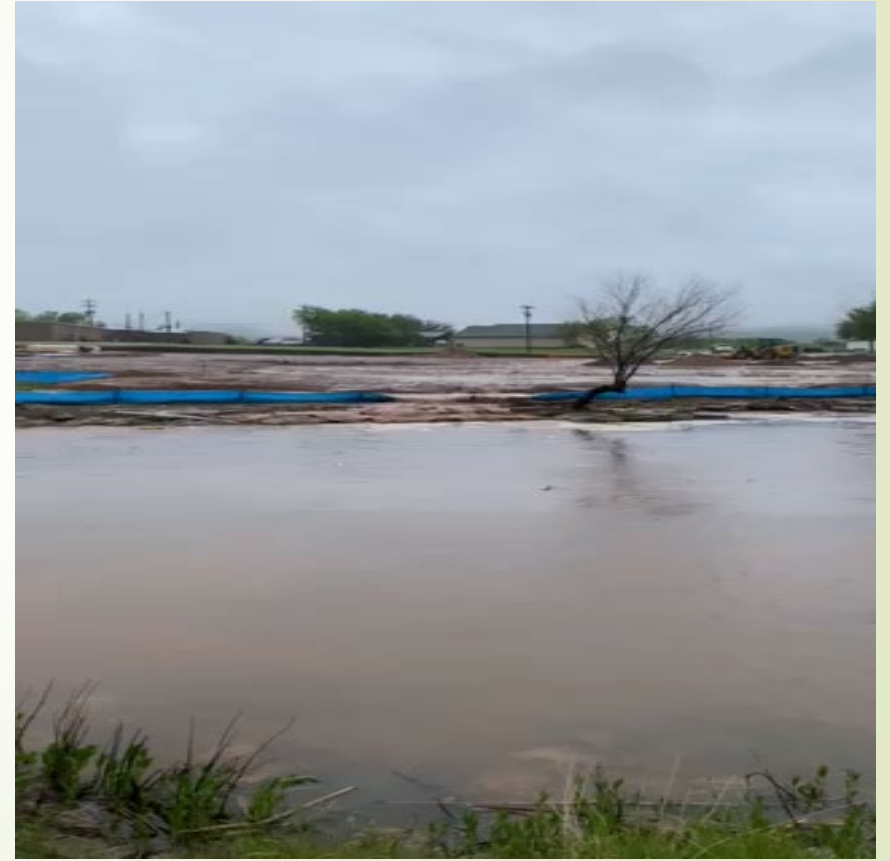
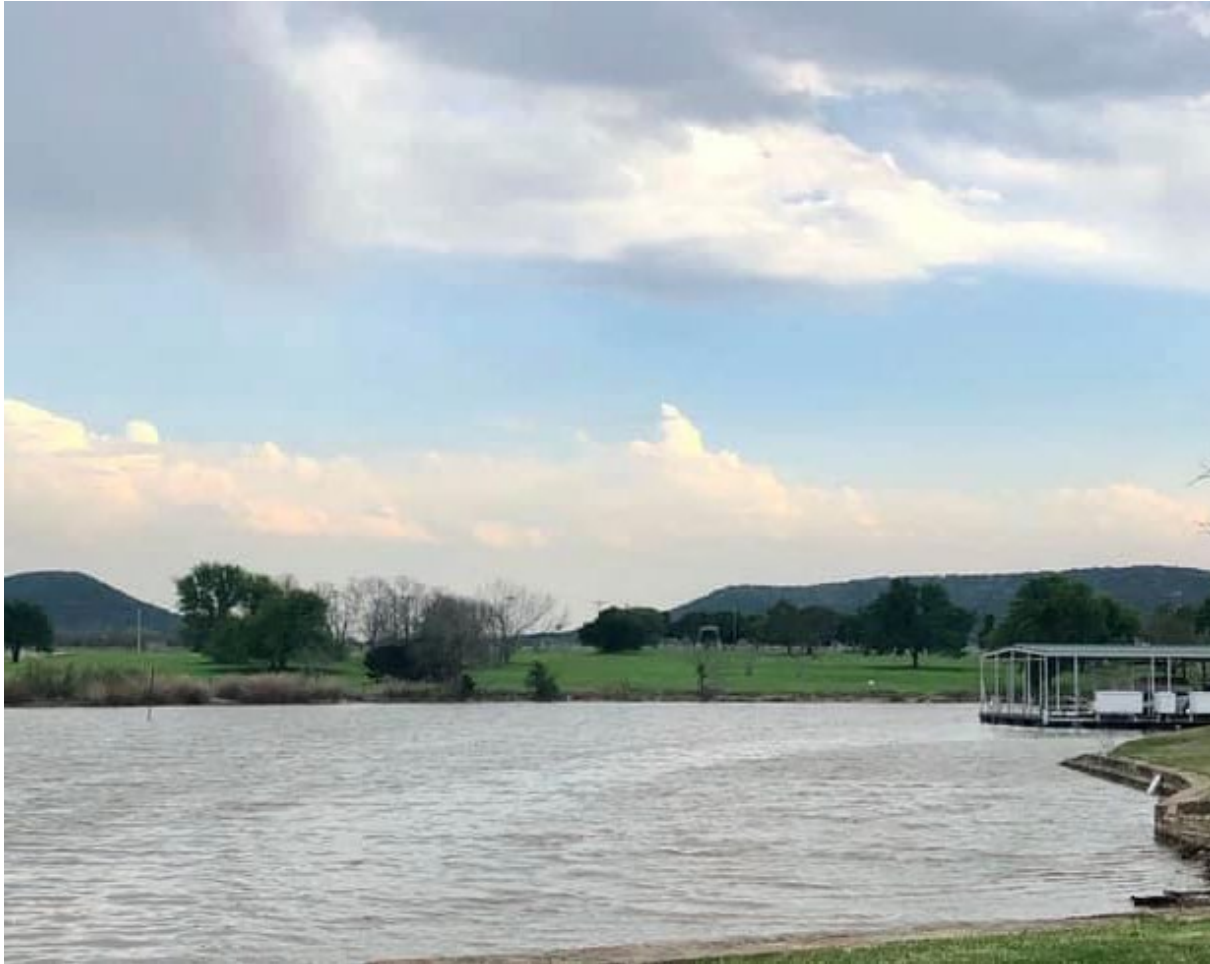
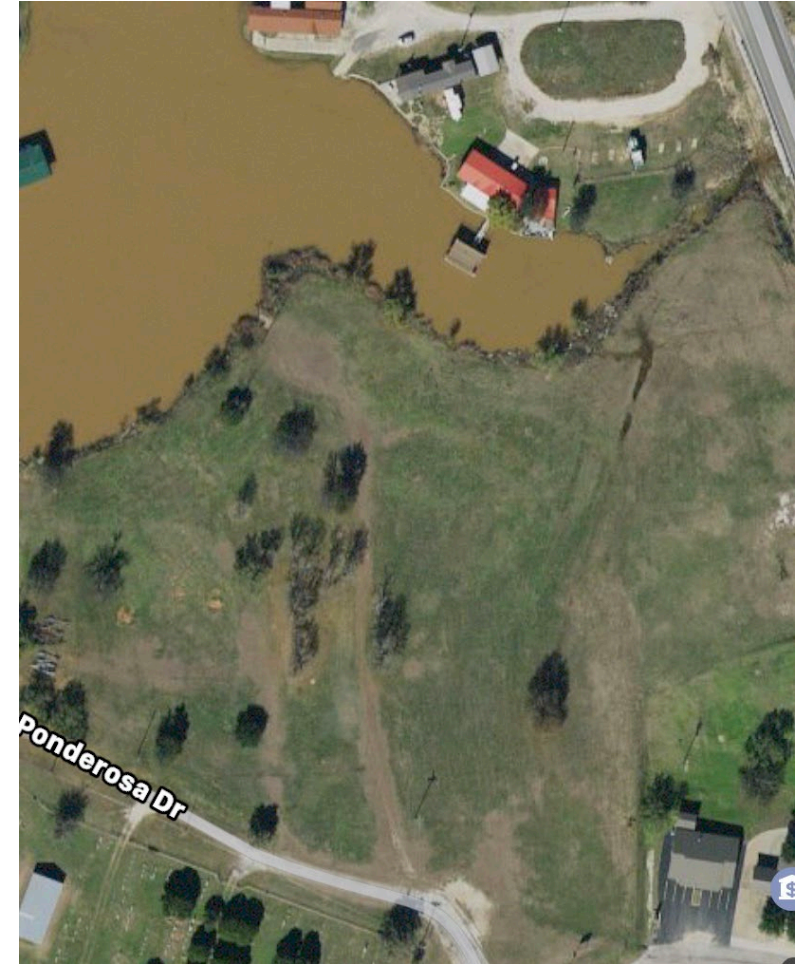
Soil Disturbance, Minimal Vegetation, and Impervious Surfaces

- Every inch of the soil on the property has been disturbed
- All vegetation has been removed
- Caliche roads and pavement to cover the property
 - Where will the vegetation be?
 - Vegetation and undisturbed soil allows for:
 - Increased saturation
 - Impeded runoff flow
 - Adequate stormwater runoff filtration

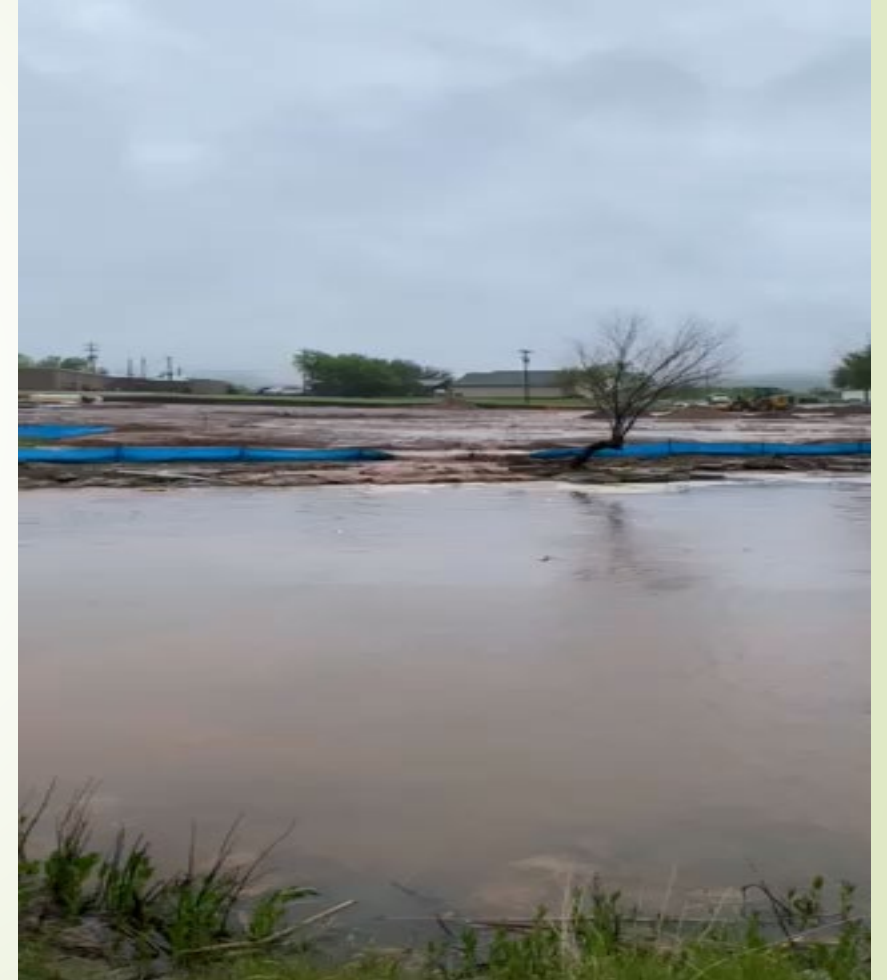
Environmental Concerns

- Sedimentation of an already small, shallow cove
- Potential runoff mixed with septic effluent
- Potential runoff from any oil, metals, or chemicals from anthropogenic sources
 - Vehicle traffic & parking
 - Heavy metals from tire wear, antifreeze, engine oil
 - RV chemicals
 - Pesticides/herbicides
