CAASLE Project, Phase III

***Presented by
Michael McClendon - Upper Basin Regional Manager
&
Stewart Vaghti P.E. - Gannett Fleming Inc.***

Morris Sheppard Dam

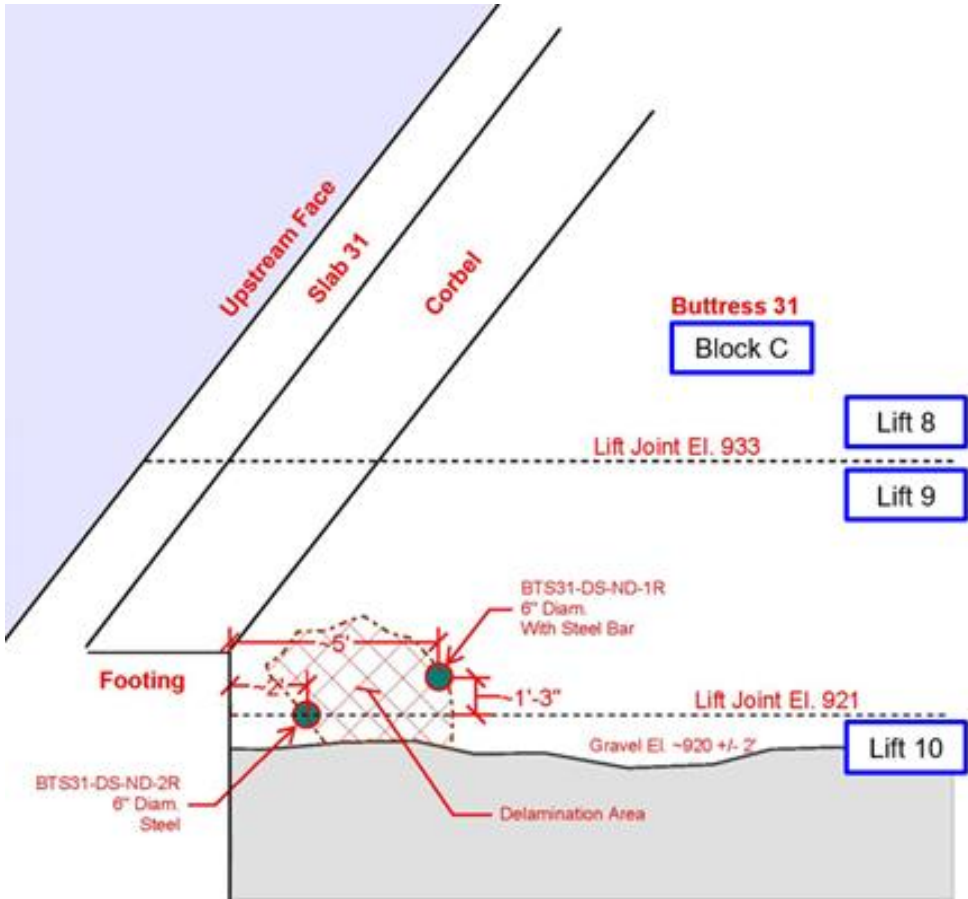
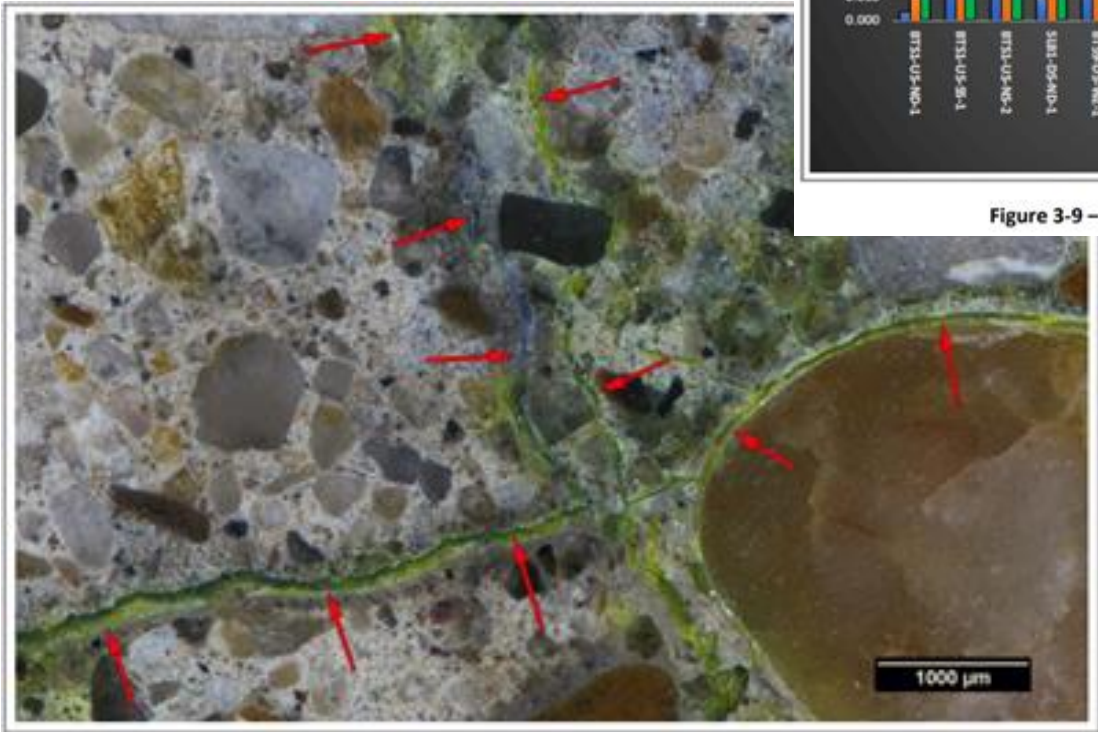
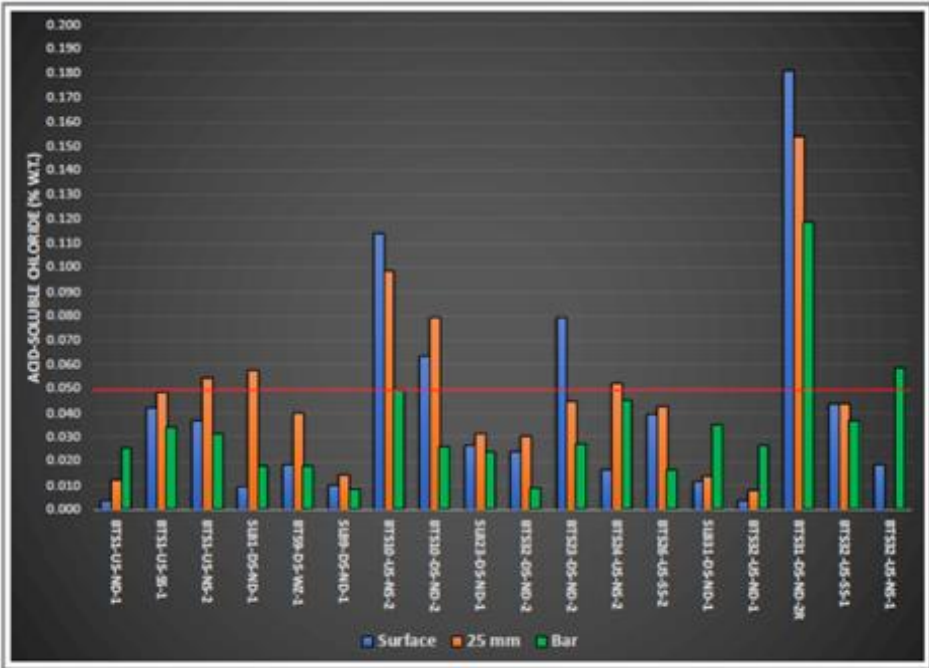
Figure 3-9 – Acid-Soluble Chloride Data Summary Bar Chart

- Expand ASR and chemical testing to see if ASR and Chloride conditions found are more widespread.
